SAWS SSO Program Achievements

Jeff Haby, P.E.

September 21, 2018

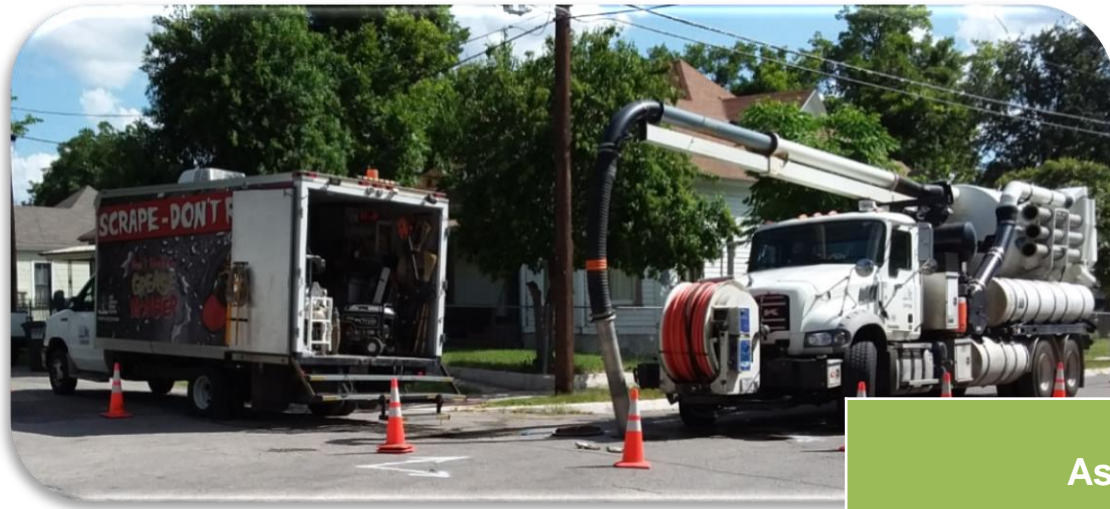
CCTV, Sonar or Pole Cam

Asset Description To be Assessed by July 2017	Miles of Inspections Required Under CD	Miles of Inspections Completed	% Complete
Small Diameter Gravity Sewer - EARZ, Concrete Pipe and Clay Pipe Installed Prior to 1973	1,869	1,909	102%
Small Diameter Gravity Sewer - Clay Pipe Installed from 1973 through 1982	410	411	100%
Large Diameter Gravity Sewer	364	378	104%

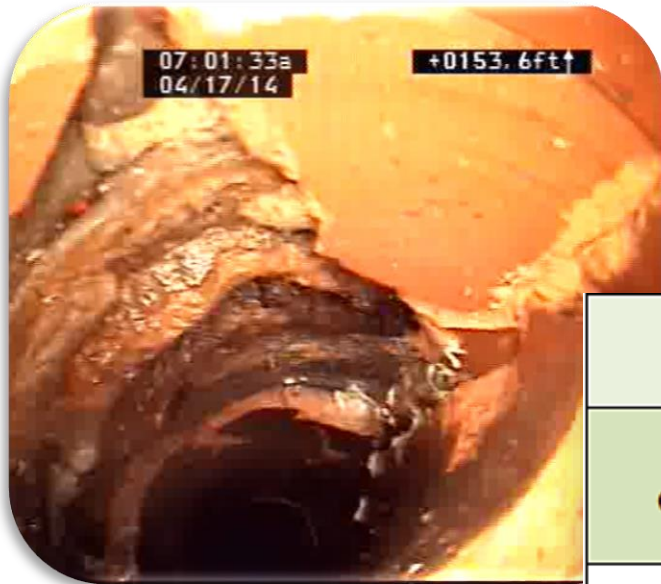
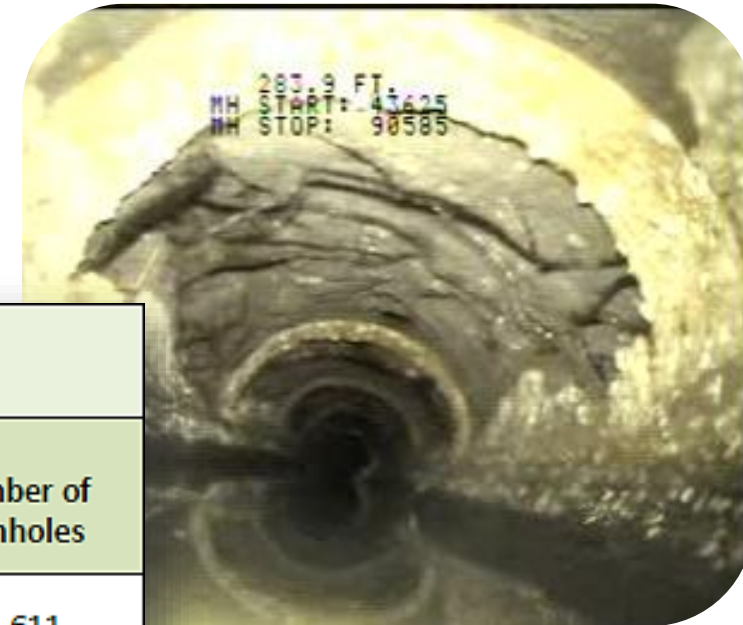
Table VII-I:
Condition Categorization Summary

Condition Assessment: Rate A-E

Condition Category	Miles of Small Diameter Sewer Mains ^{1,2}	Miles of Large Diameter Sewer Mains ^{1,3}	Number of Manholes
Category A – Very Good	1,019.32	79.22	21,611
Category B – Good	415.67	52.72	32,406
Category C – Fair Condition	1,156.74	114.29	270
Category D – Poor	332.26	83.18	1,171
Category E – Very Poor	178.93	32.27	262
TOTAL	3,102.92	361.68	55,720

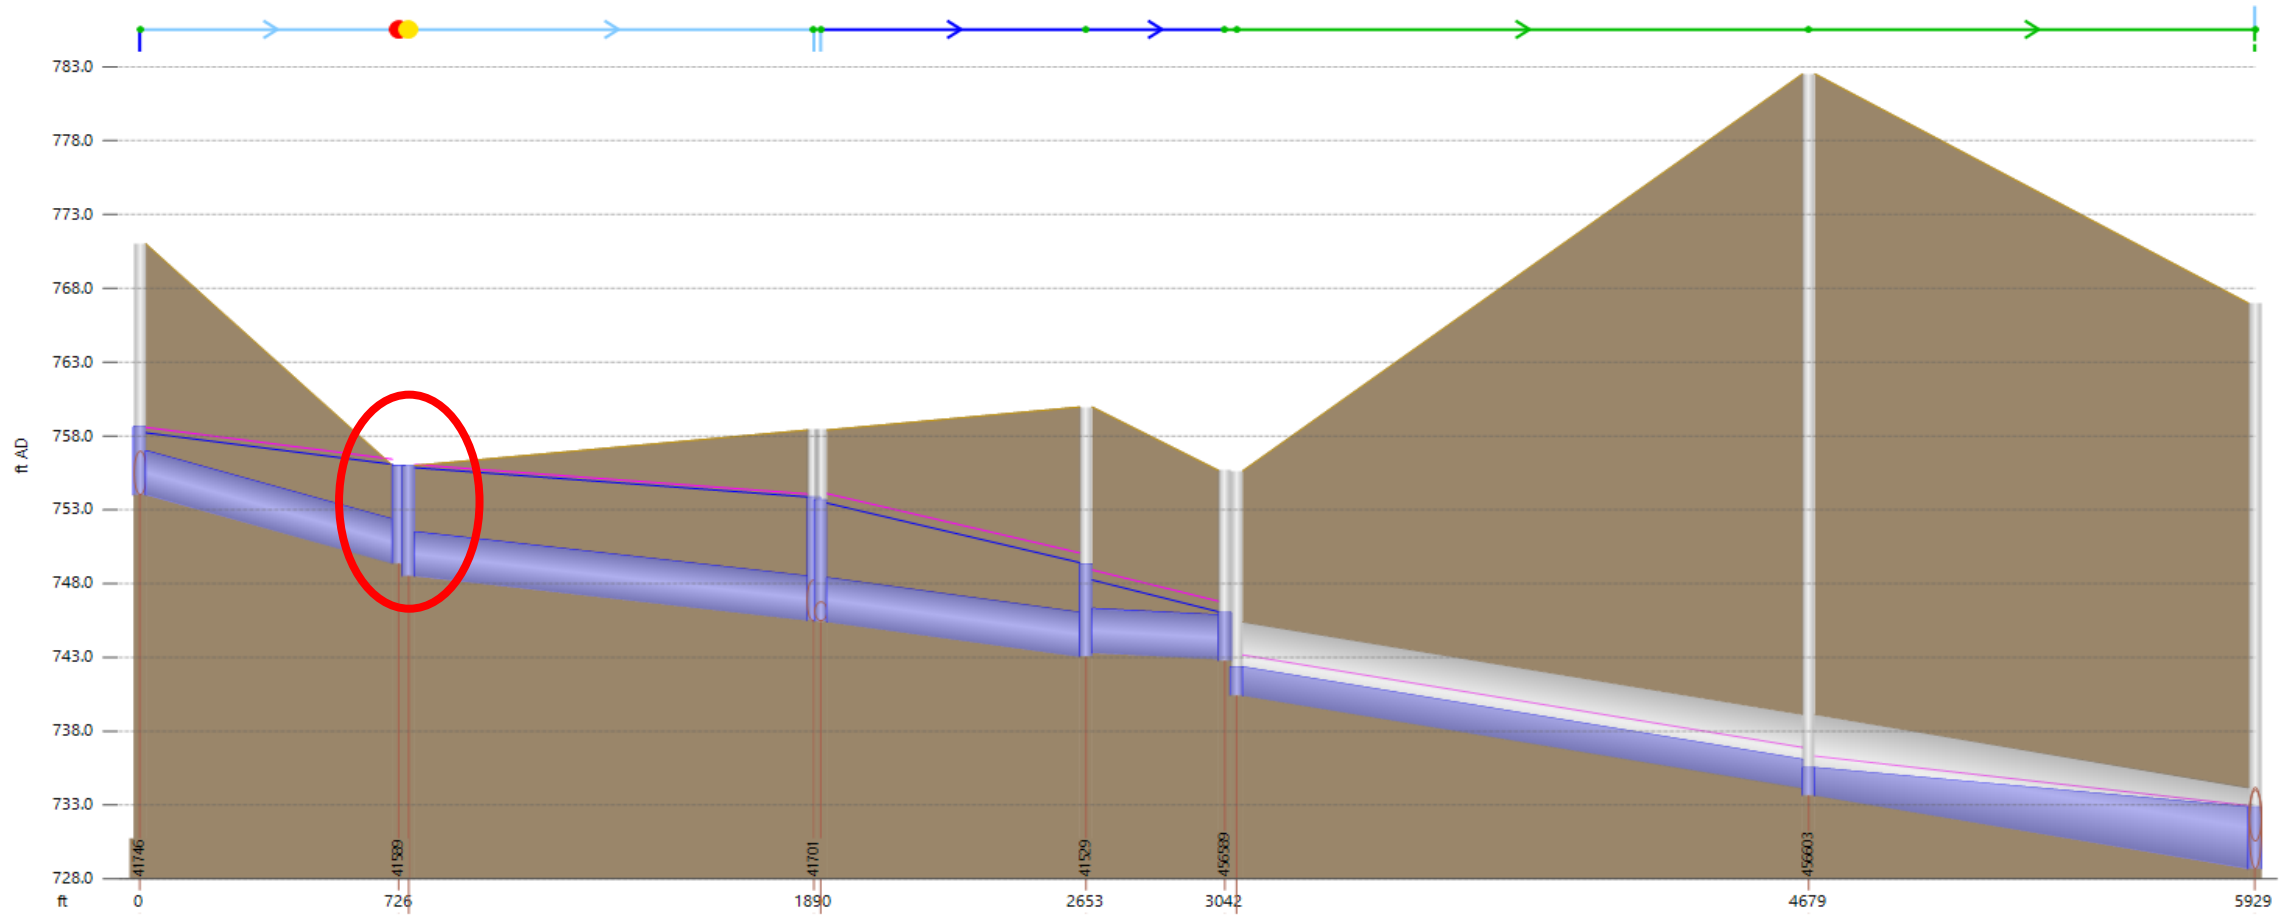
What is a Capacity Constraint?

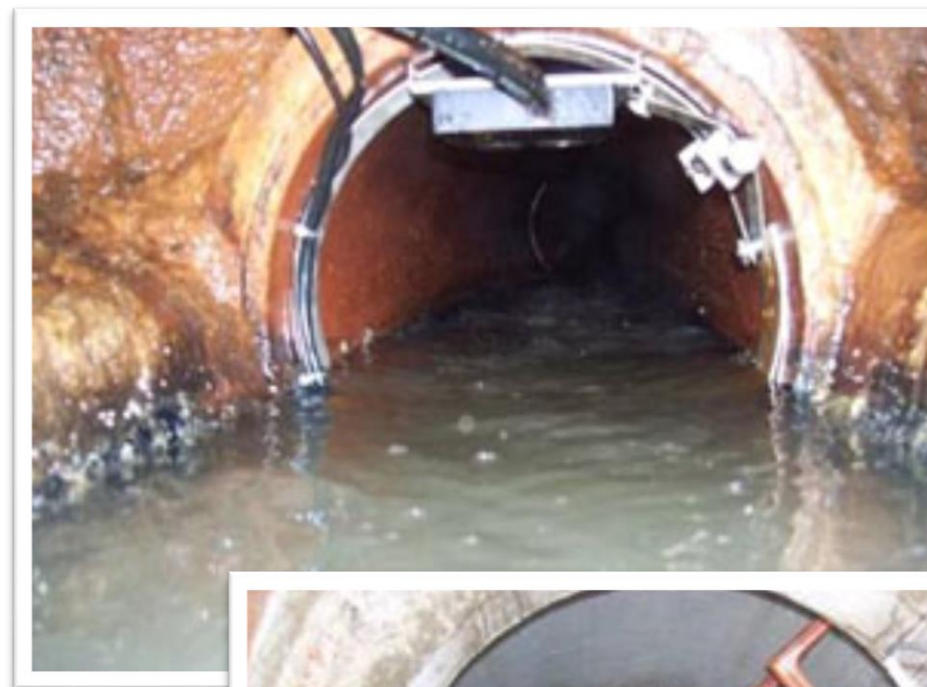
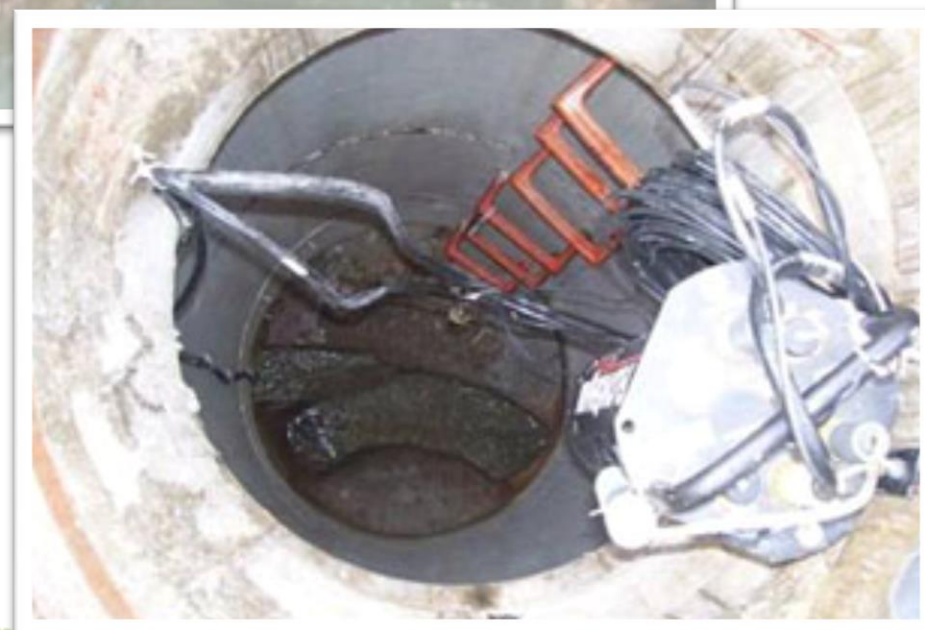
Flow Monitoring Program

- Flow Meters (>200 flow meters)
- Rain Gauges
- Flow Monitoring Contracts
 - Model calibration
 - Inflow & Infiltration studies
 - Capacity Validation

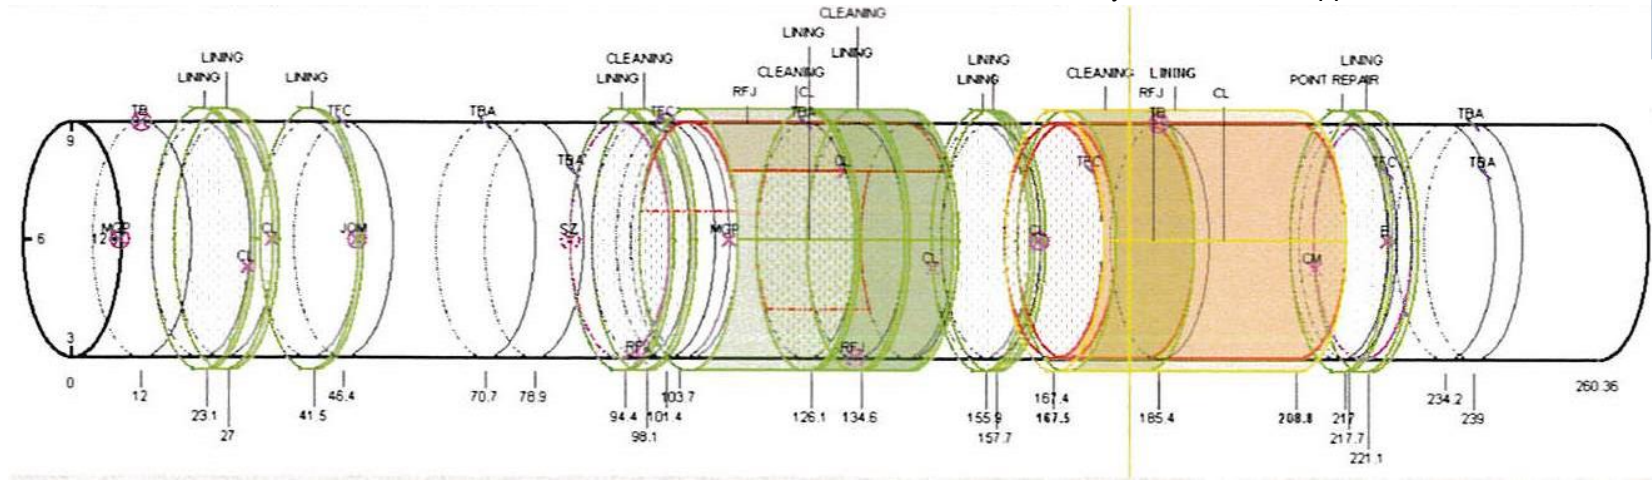
PACP Coding

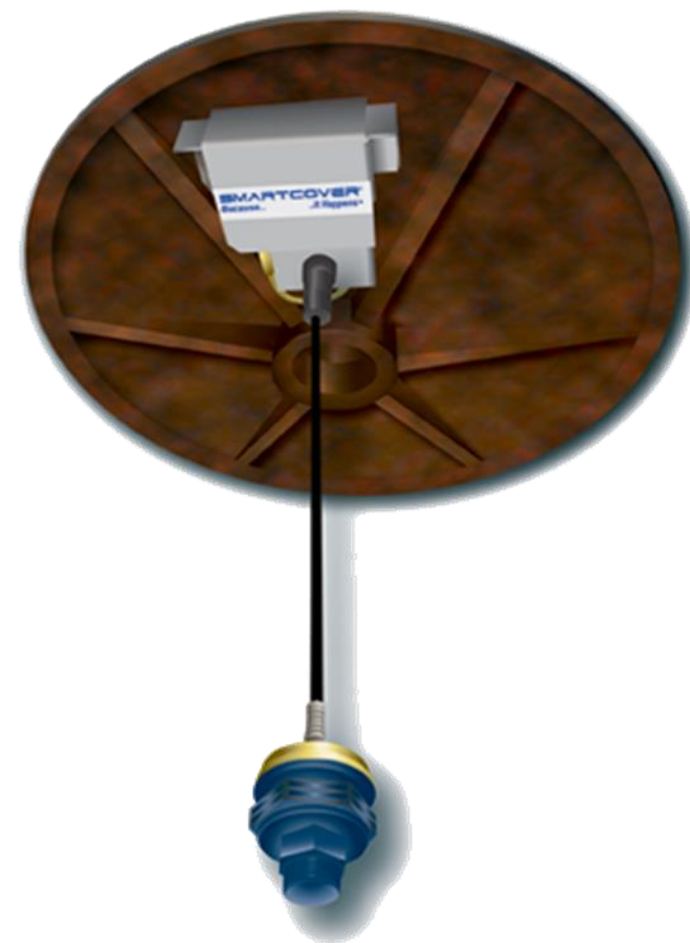
Smart Clean Program

- Smart Clean Covers will be installed on 200 manholes
- Resource optimization through trend analysis and remote alarm system integration

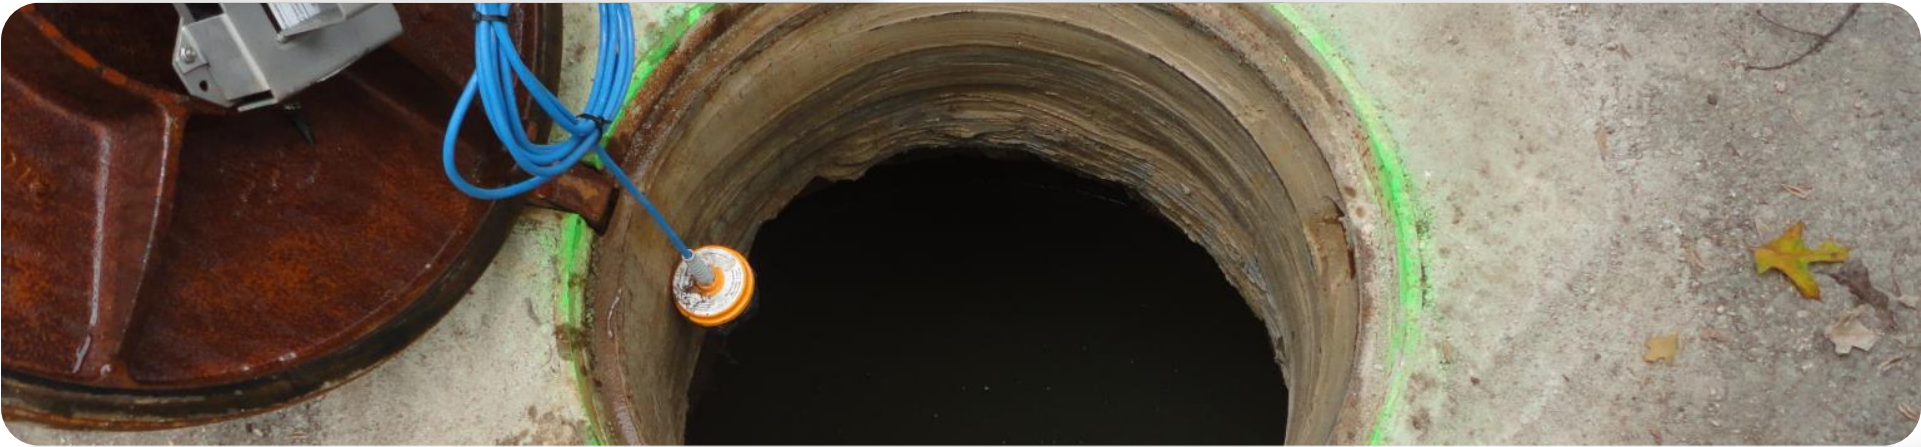
Manhole Lid
Testing

Manhole Defect

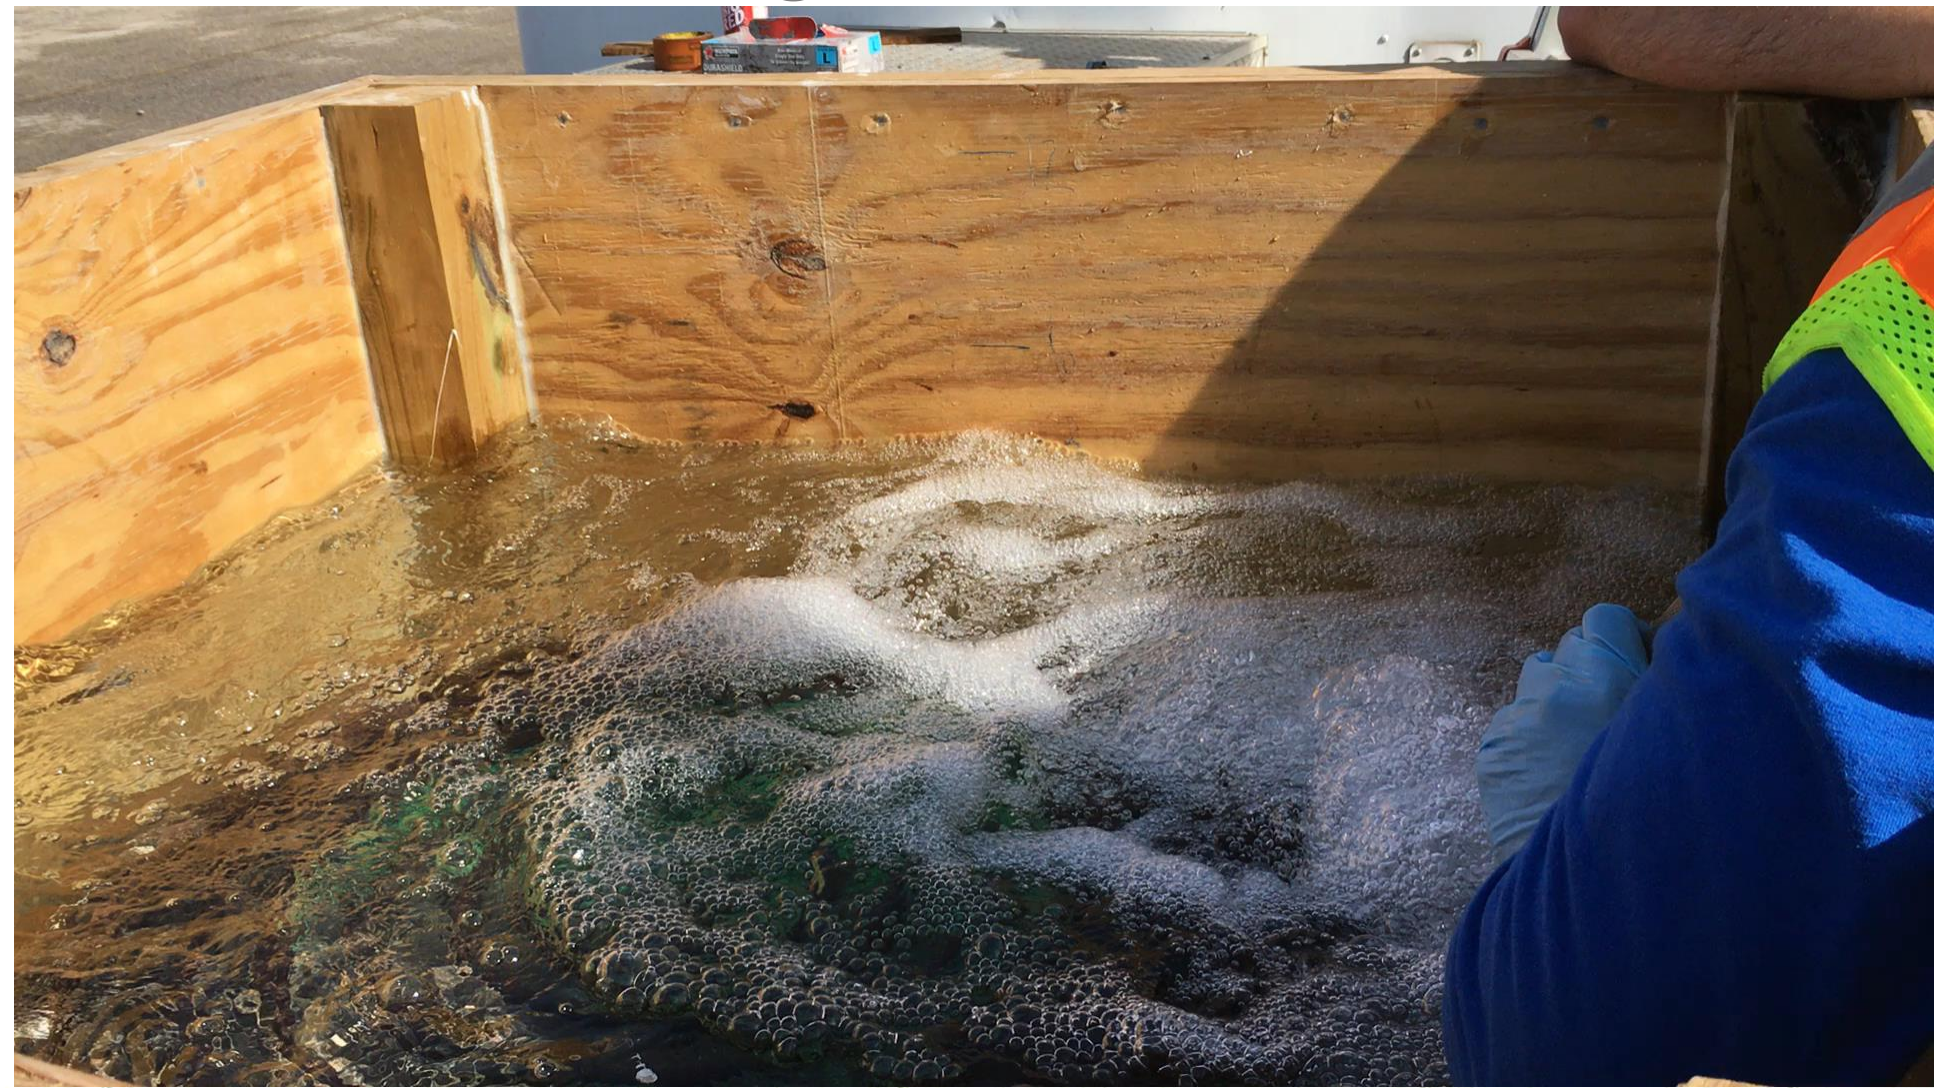
Manhole Testing: What is the MH Cover

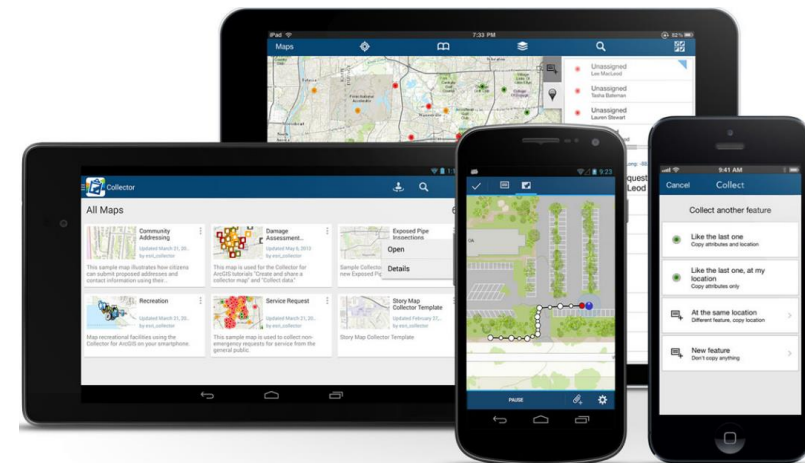
Manhole Inflow Reduction (MIR) Program

- Deployed Mobile Application in July 2017
- Integrates with existing ArcGIS solutions at no additional cost to SAWS

- 100 Year Flood Plain & Low-Lying Creek Beds (Phase 1)
- Total of 8588 manholes

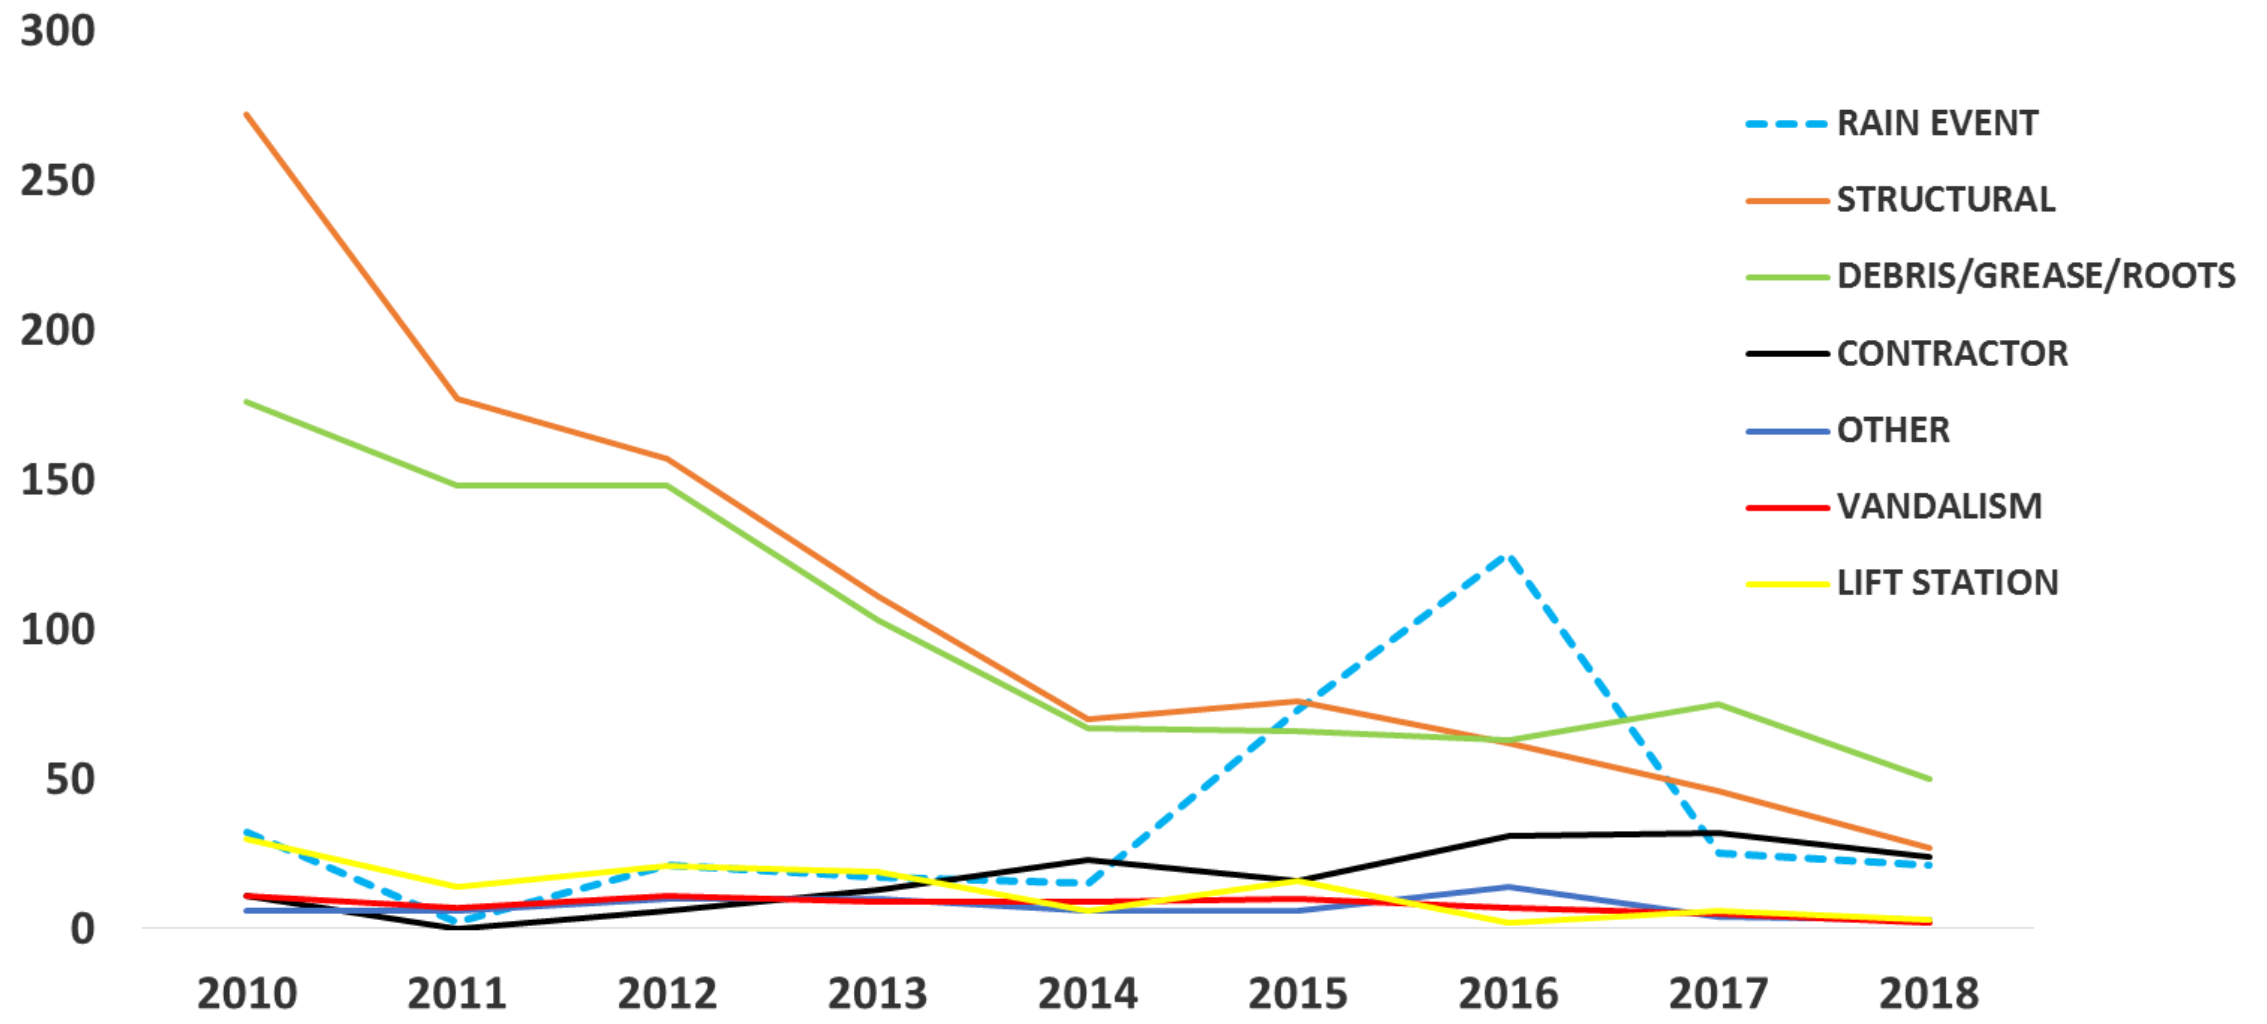
SSO Root Cause

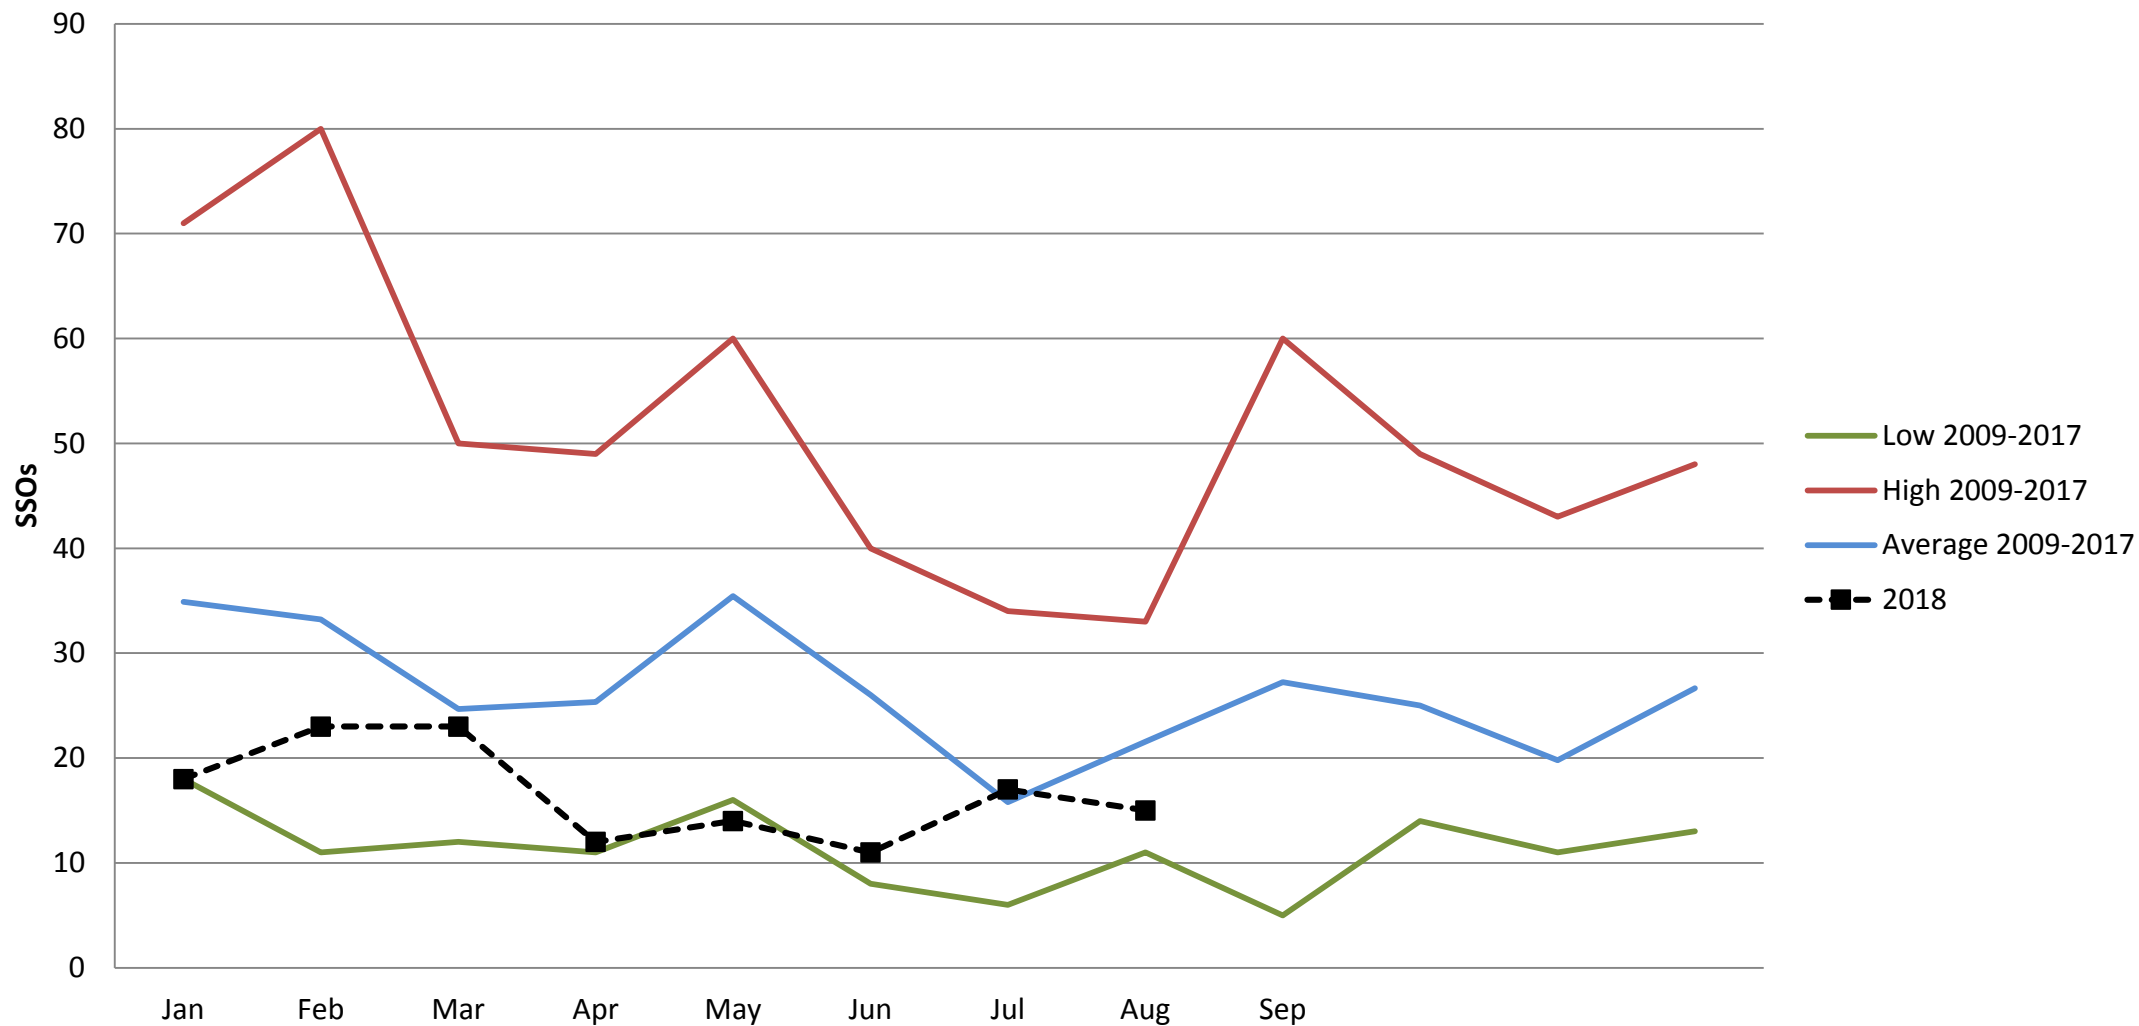
Program Effectiveness

193 SSOs for 2017 a record low!
Note: SAWS owns the lower lateral

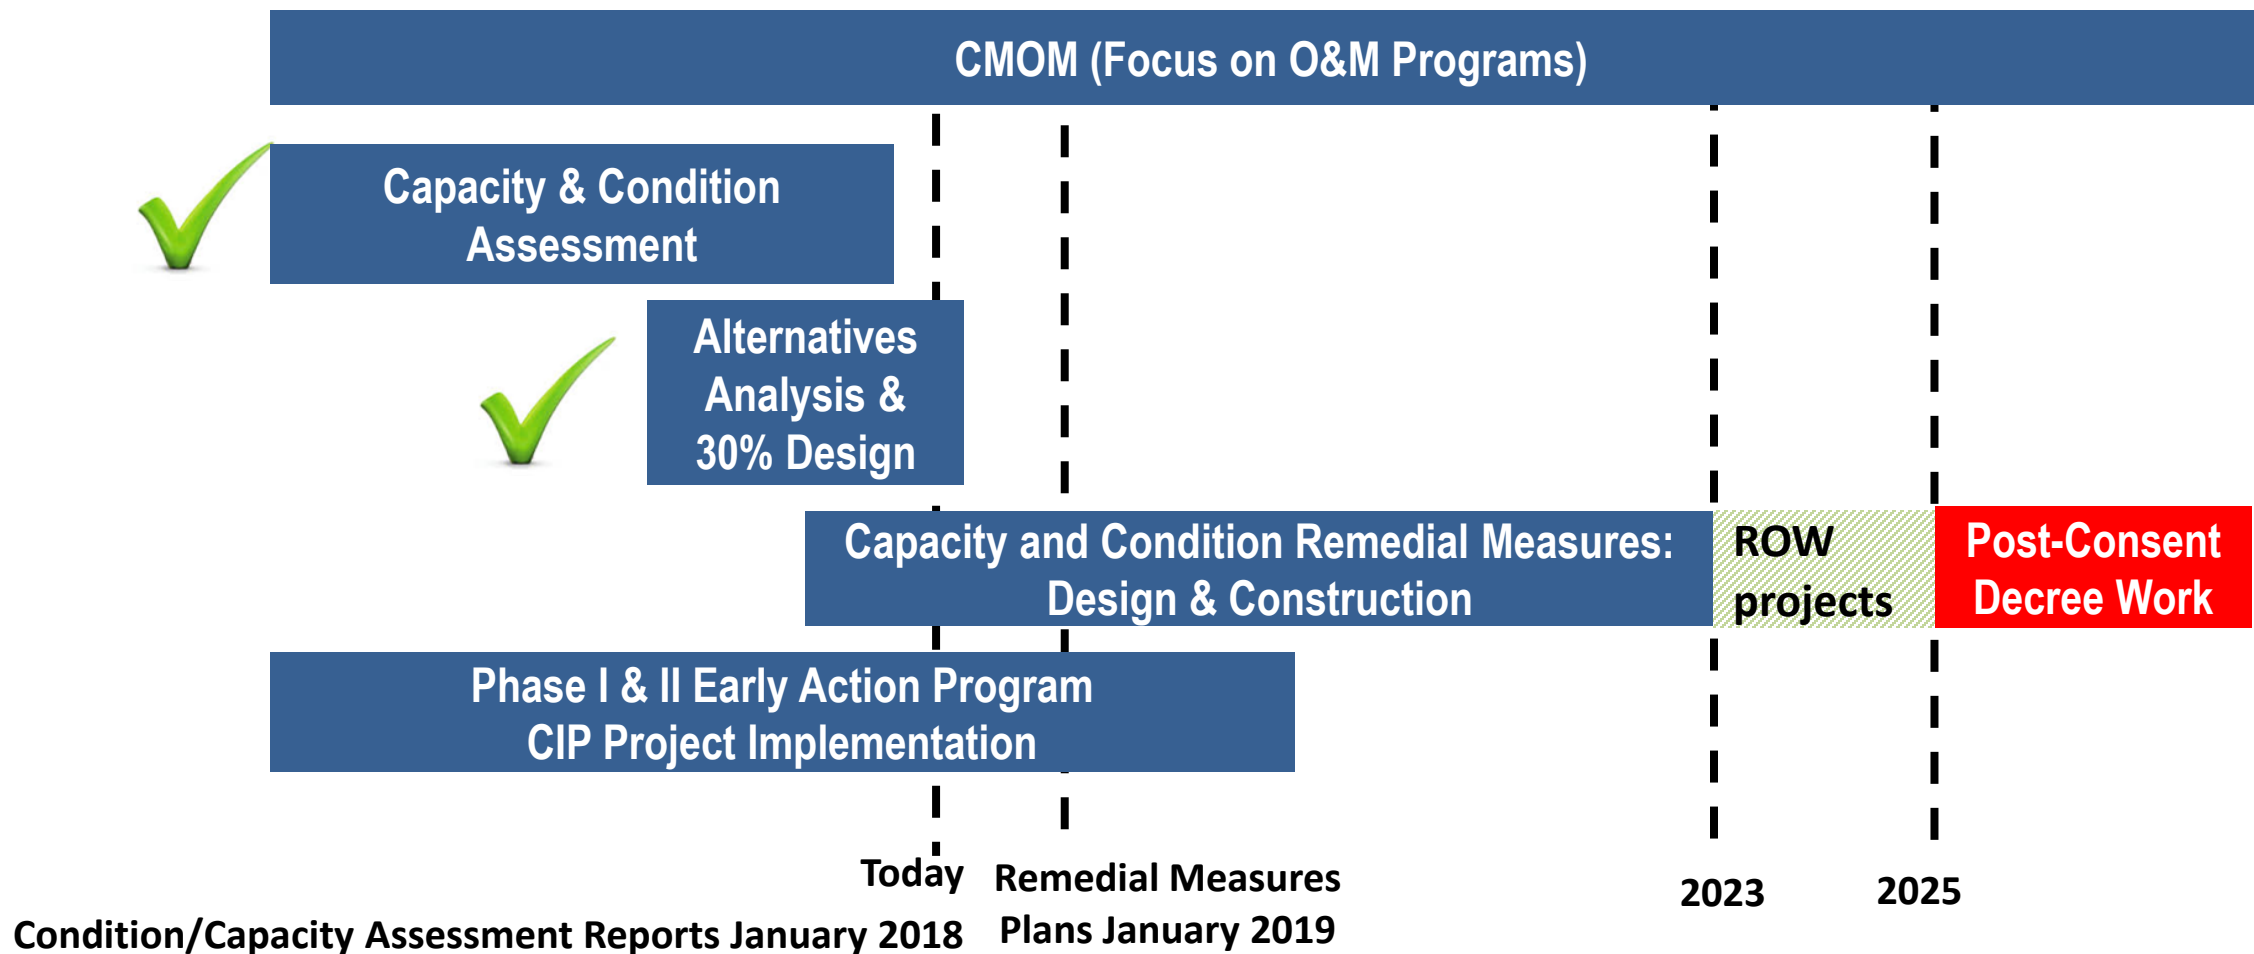
SAWS Consent Decree Timeline

Nearing Completion of the Alternatives Analysis Phase
