SAWS SSORP Progress

Jeff Haby, P.E.

September 13, 2019

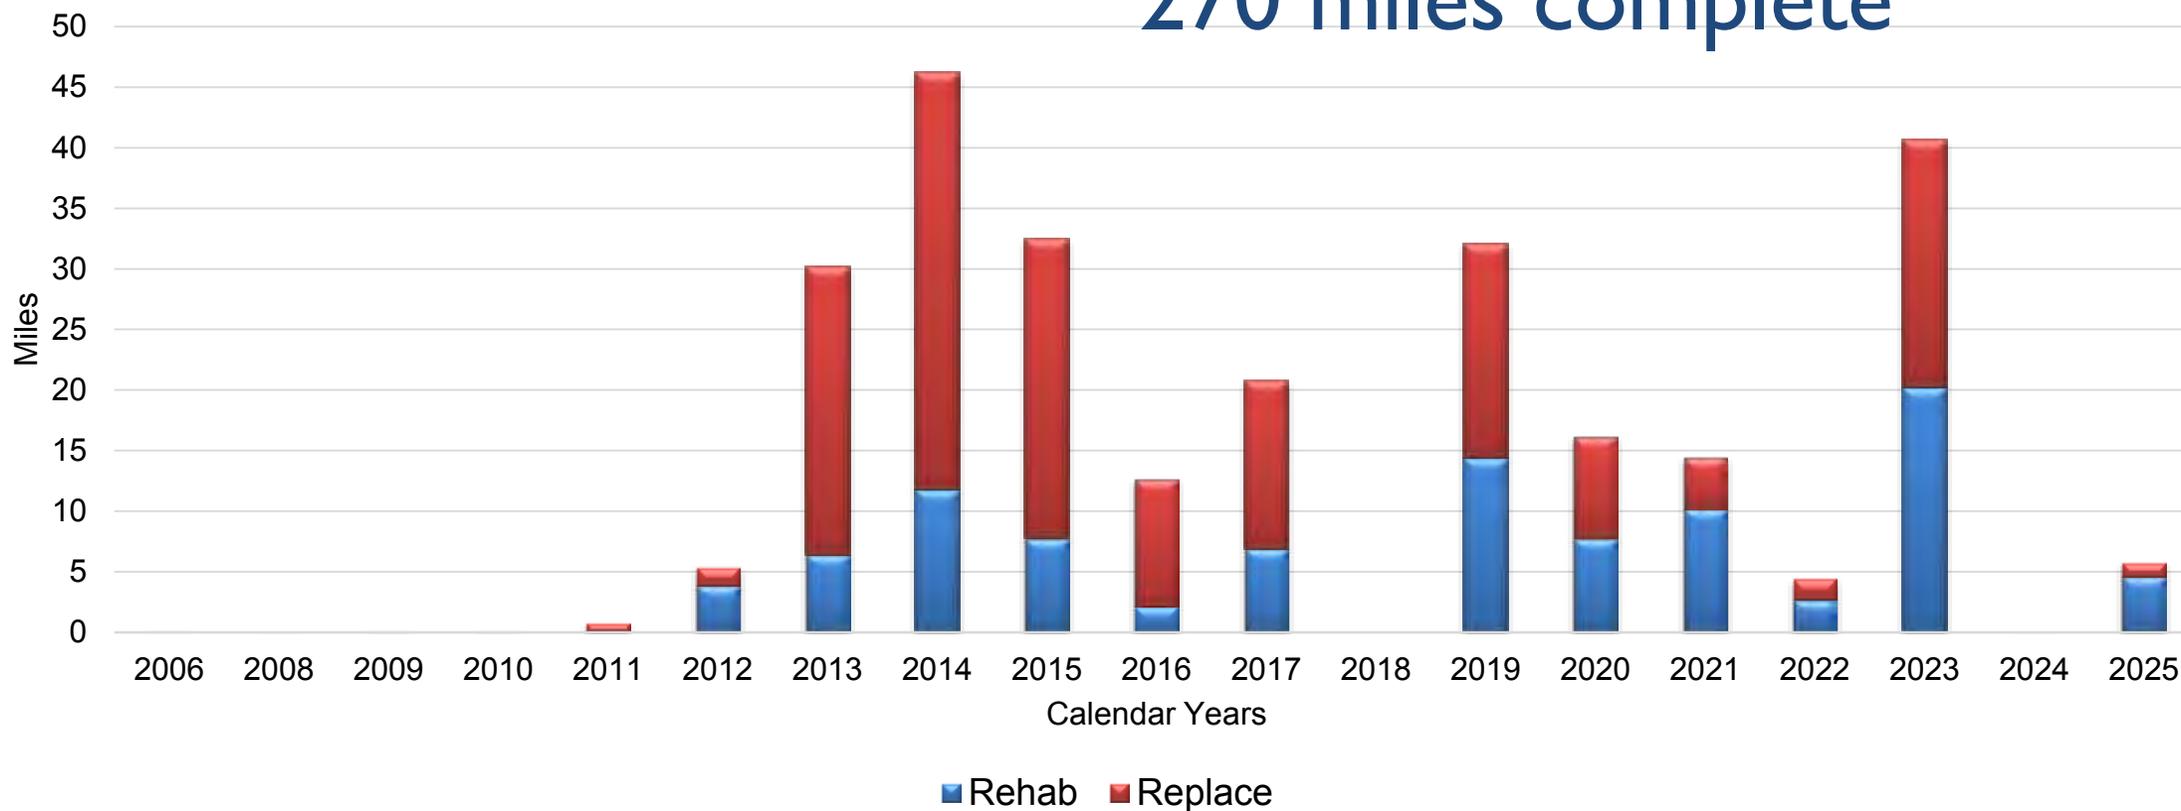
Condition Mileage

Completed, Planned Rehab and Replace Mileage

270 miles complete

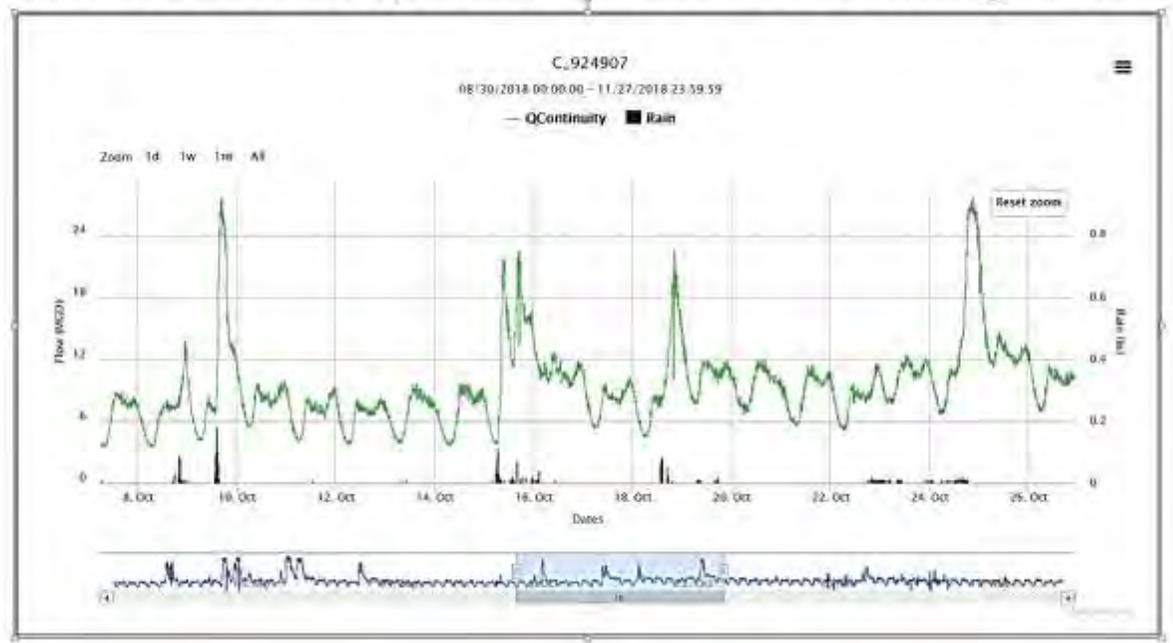
Wet Weather Response – Poor Performing Area

Flow Monitoring

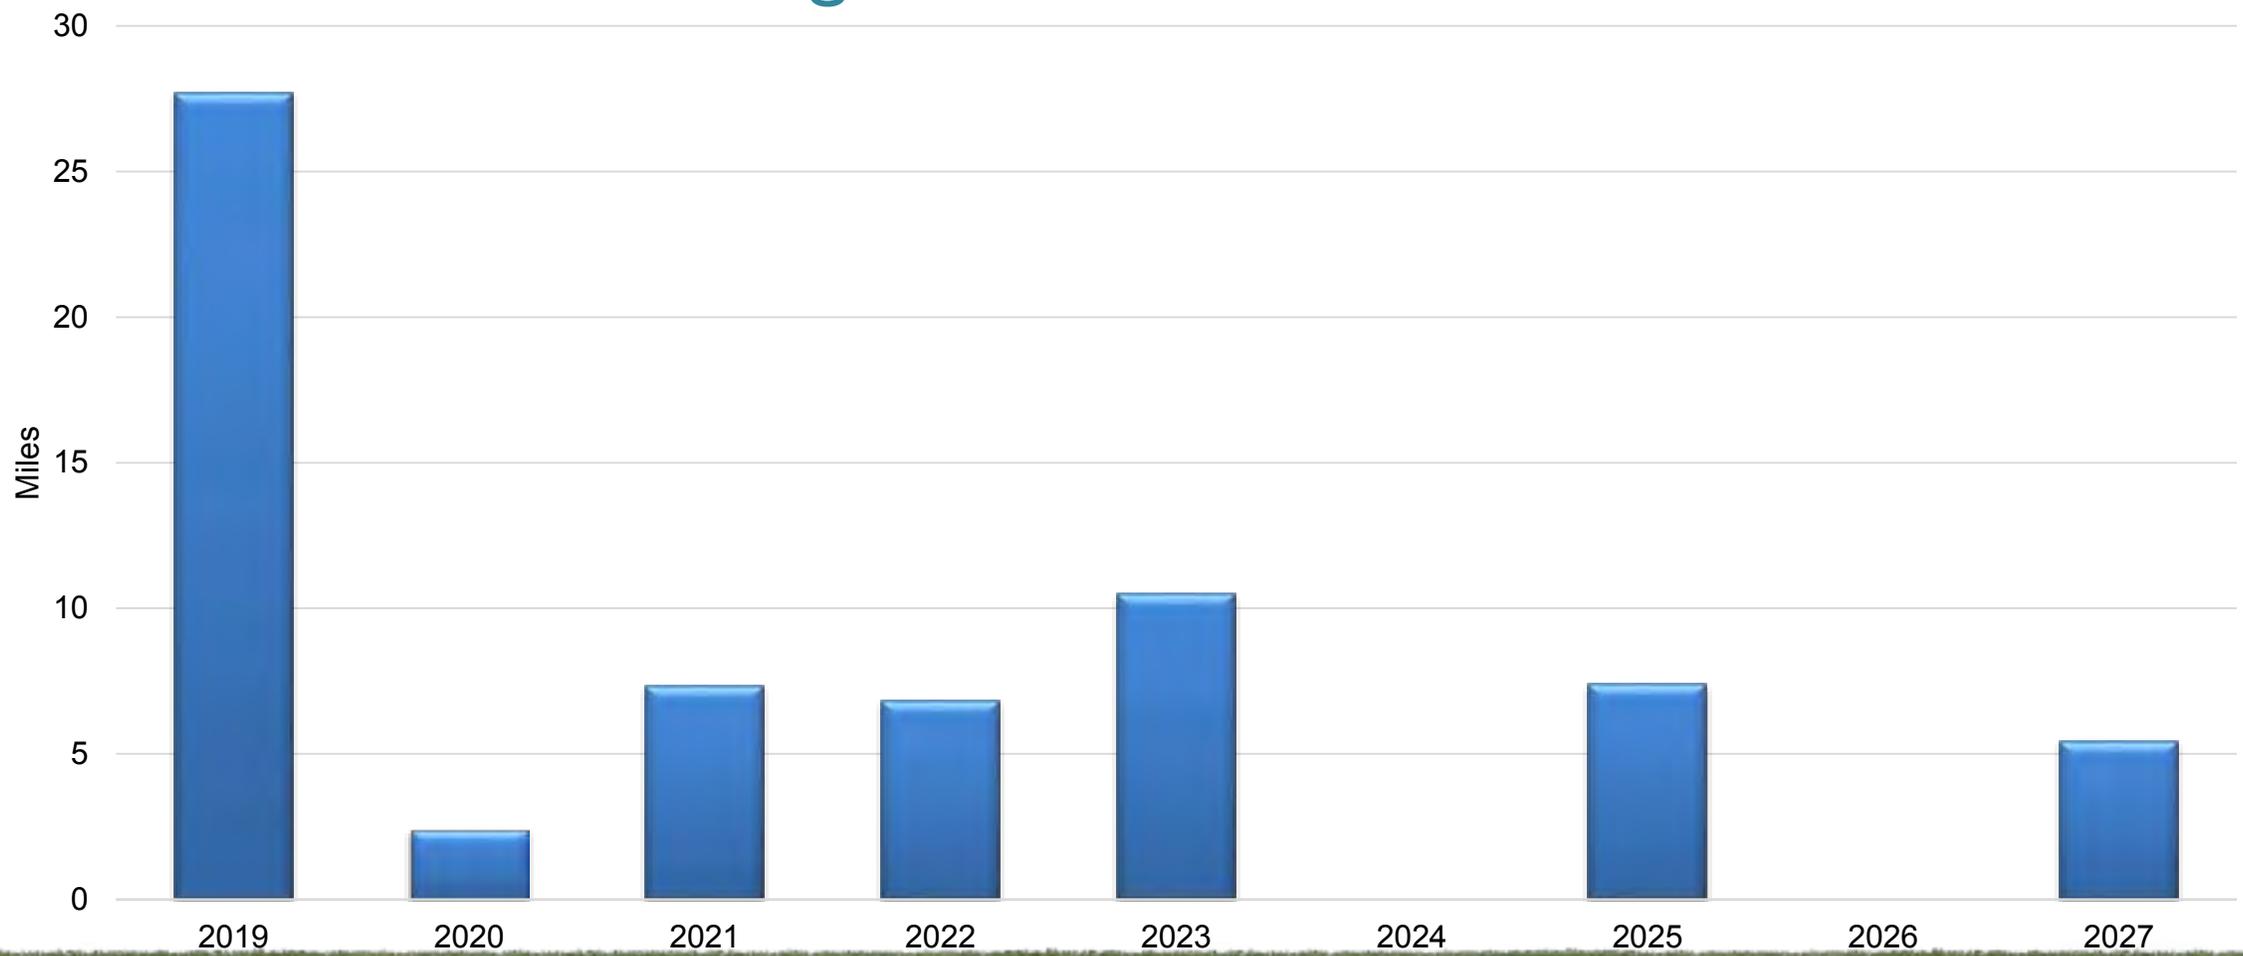
Capacity Projects

67.5 miles remaining

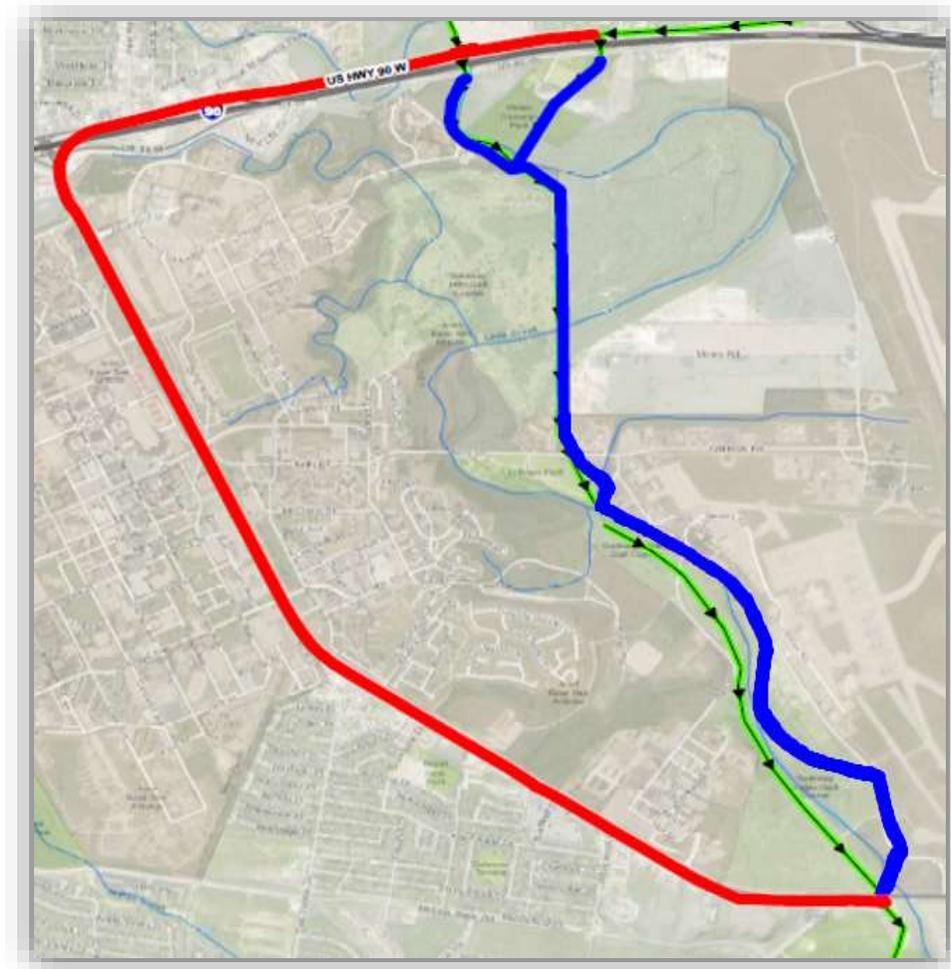
W-6 Final Alignment & Schedule

- \$175-210 Million construction cost
- Most costly sewer project in San Antonio history
- Highly specialized construction
 - 5.3 miles tunneling up to 140 ft. deep
- Aggressive Schedule
 - Design: Feb. 2019-Feb. 2020
 - Construction: June 2020-2023

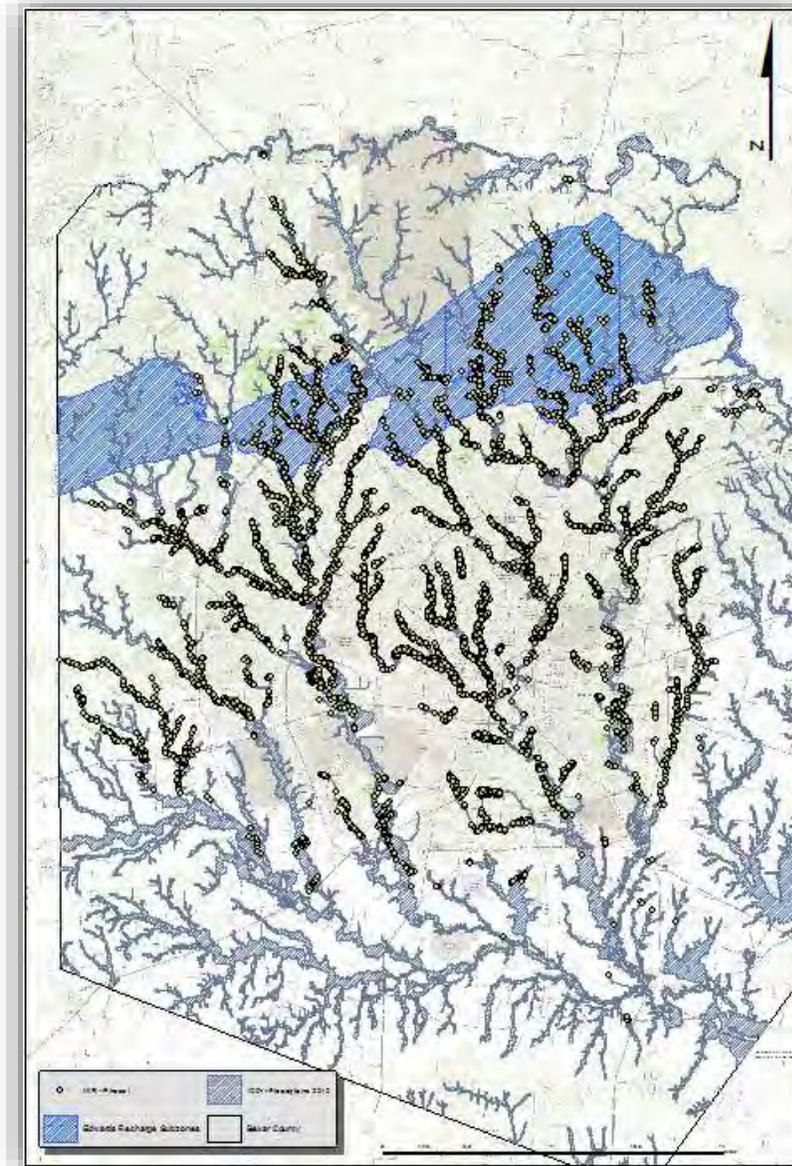
Phase I – Manhole Inspections

- 8,885 Manholes within 100 year floodplain & creekbeds
- 9% of SAWS manholes are located in the 100-year flood plain

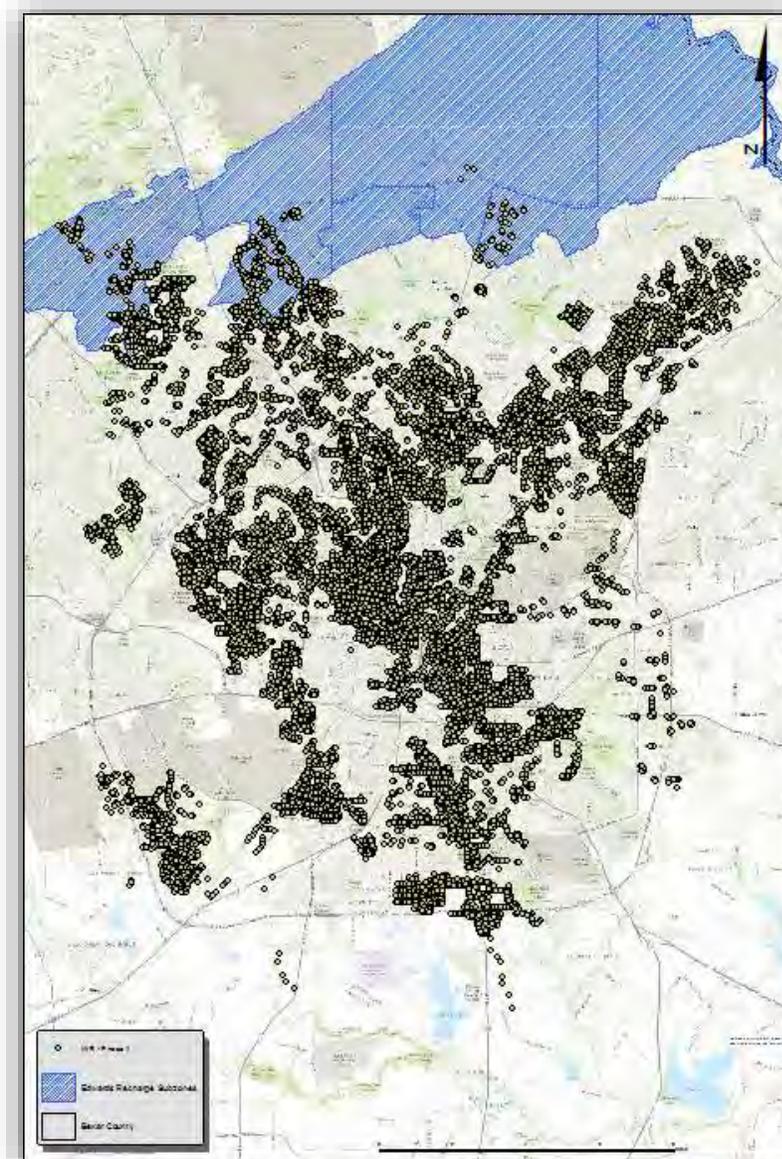
Phase 2 - Manhole Inspections

- ~20,000 manholes in flood prone areas
- Selection Criteria:
 - Upstream of capacity constraint
 - Rain event submergence

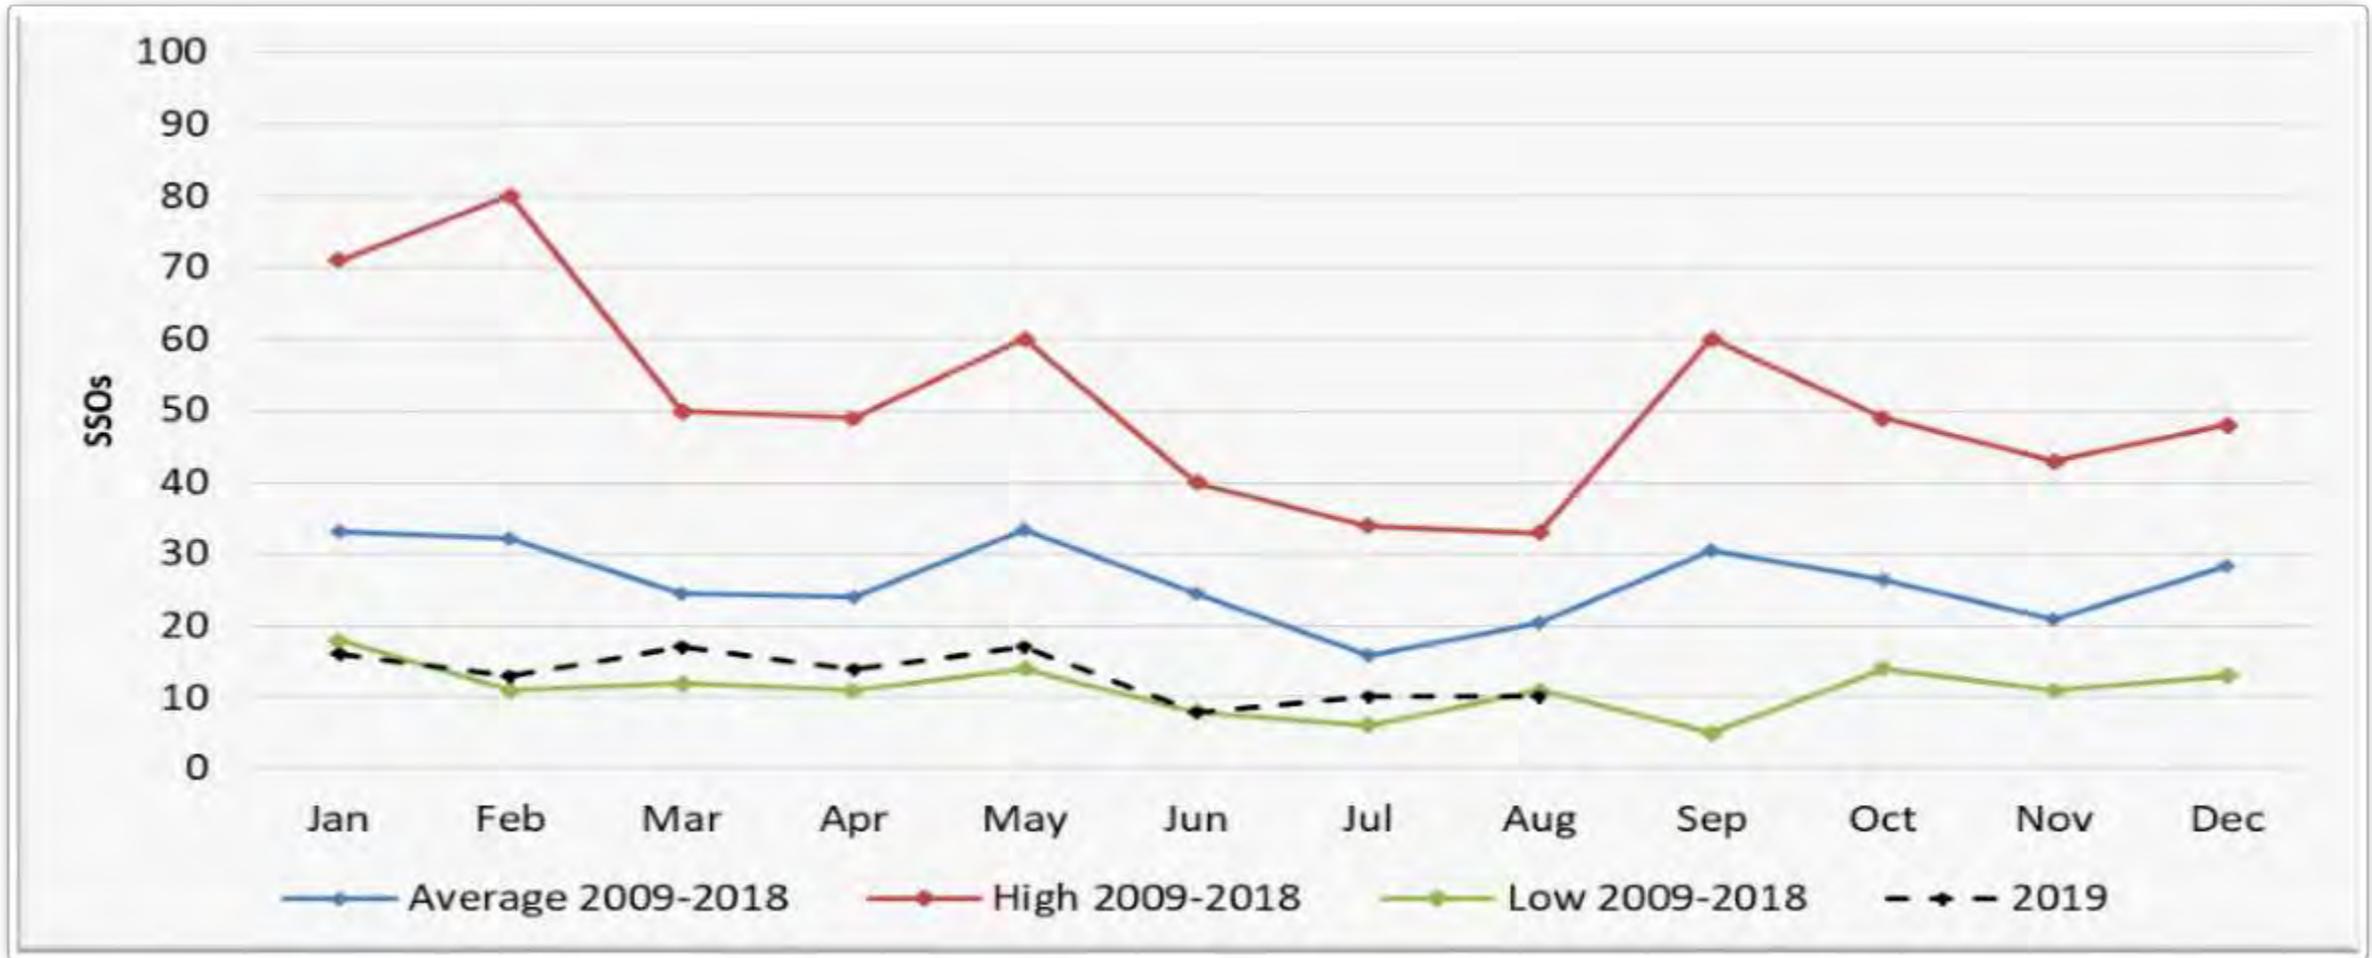
SSORP Progress

105 SSOs in 2019

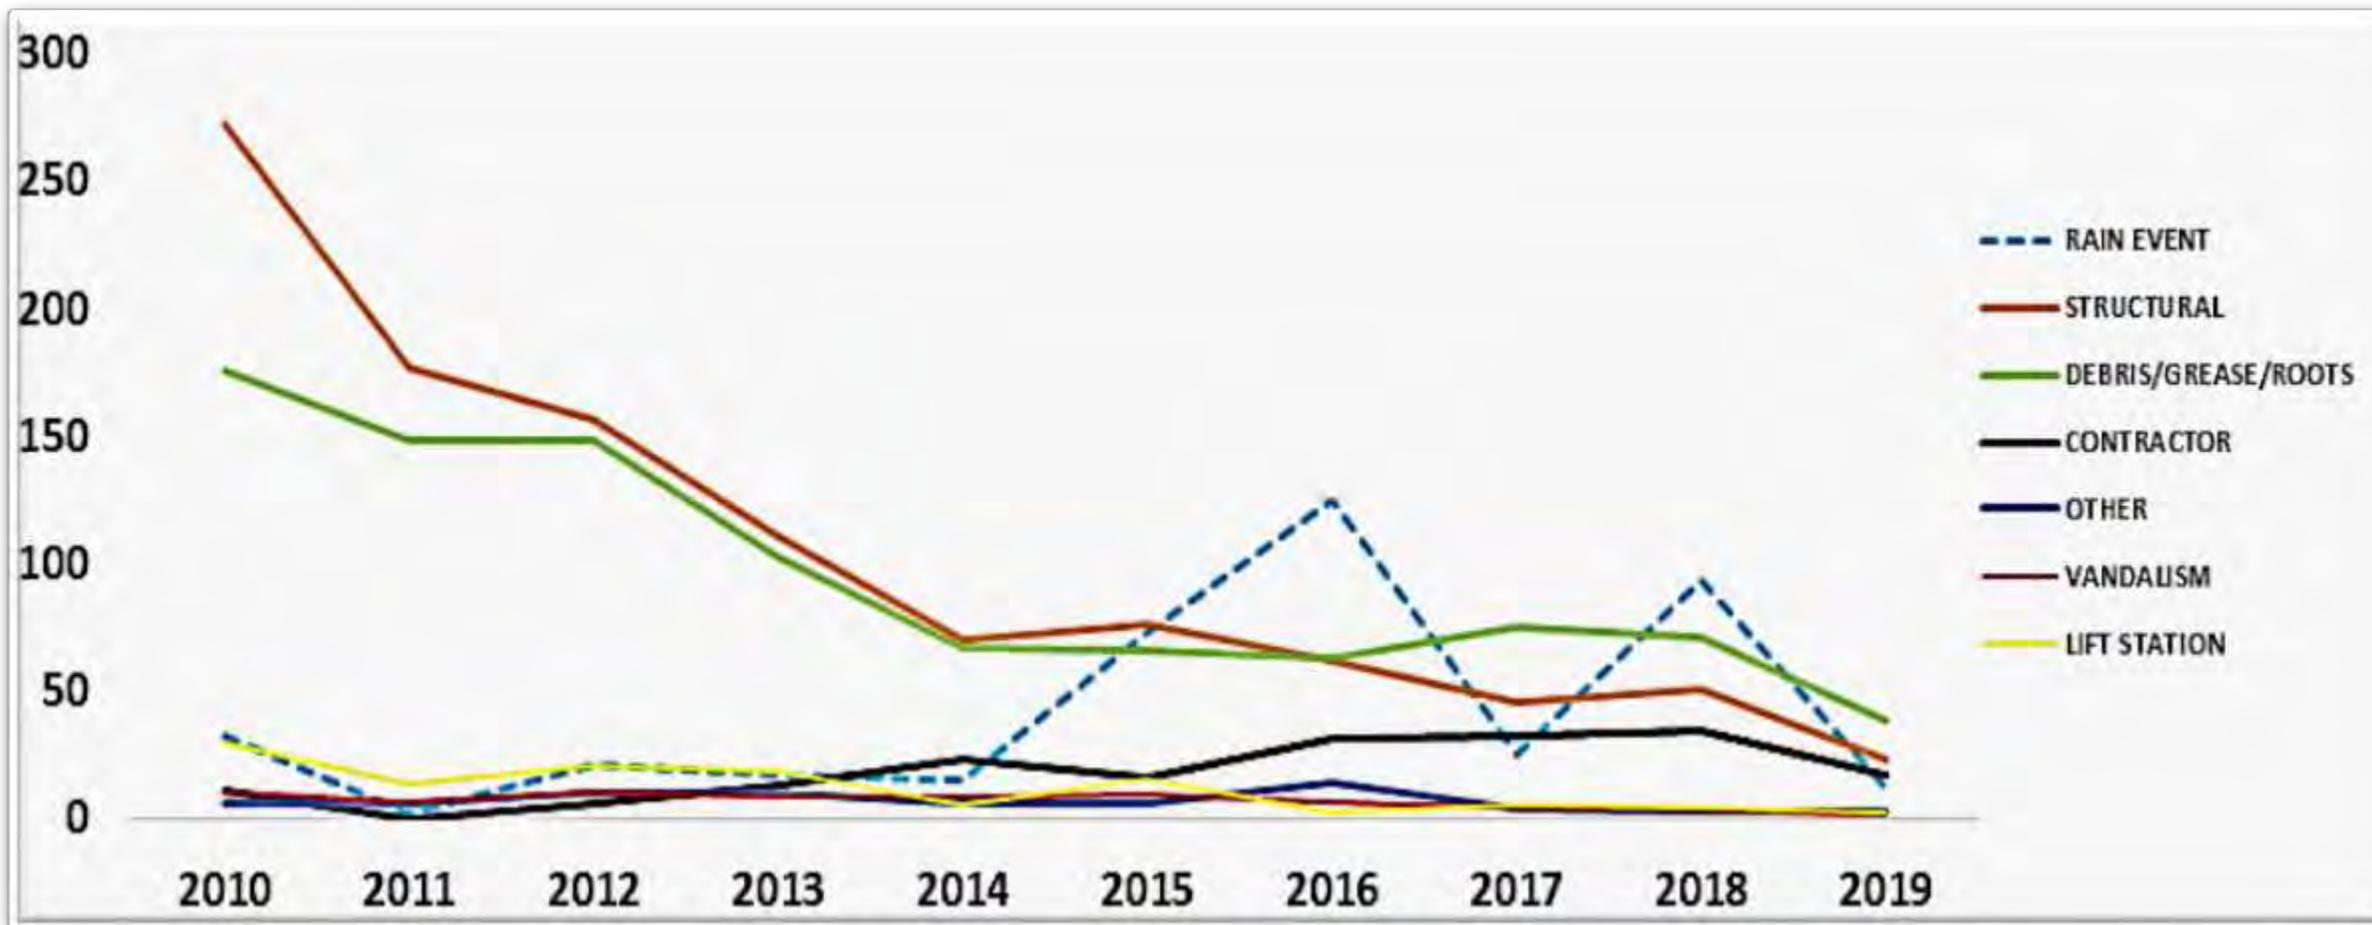
Program Effectiveness

2010-2019 YTD SSOs by Root Cause
