# Bringing Innovation into the Smart City

# The City Of Arlington

# Large Diameter Sanitary Sewer Assessment Program

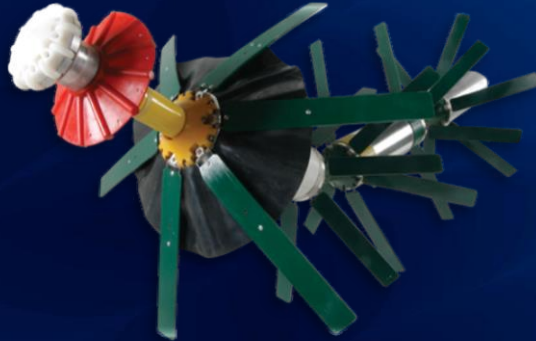
# Water Main Condition Assessment

- 2.6 miles, 42", 48" & 54", Prestressed Concrete Cylinder Pipe (C301), 1982
- Estimated Replacement Cost \$10,500,000
- Assessment Cost \$286,500

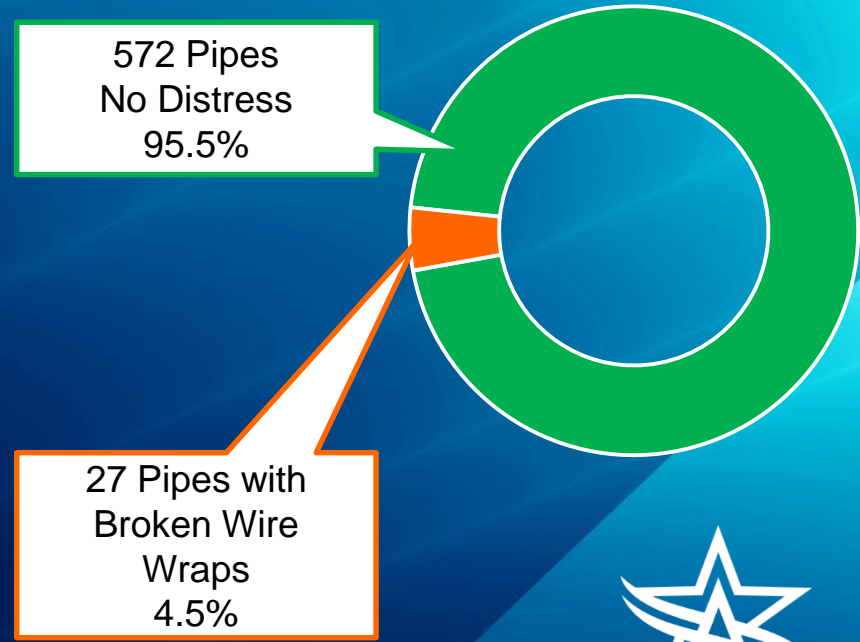
# Water Main Condition Assessment

## ■ Assessment Results

- 599 pipe segments
- 27 segments with wire breaks (4.5%)
- 6 segments with 25+ wire breaks (1.0%)
- Cost avoidance of \$7,000,000

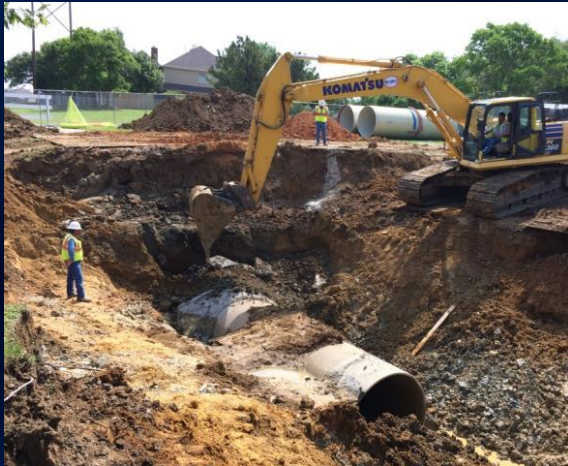
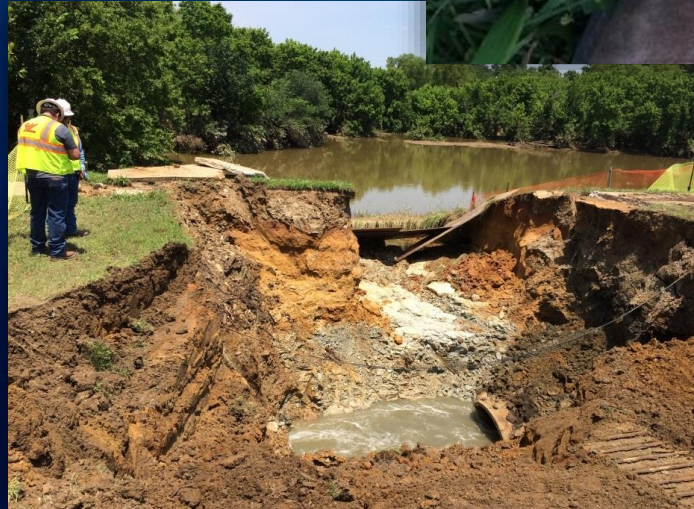
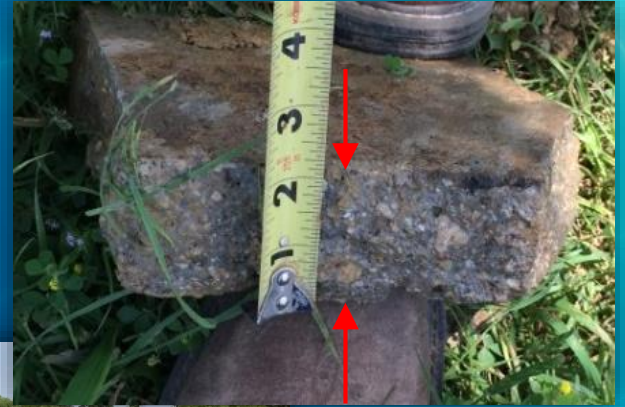
# Large Sewer Main Failure

- 35 Year old Main
- 66-inch RCP Sanitary Sewer
- 50% of the City's Flow

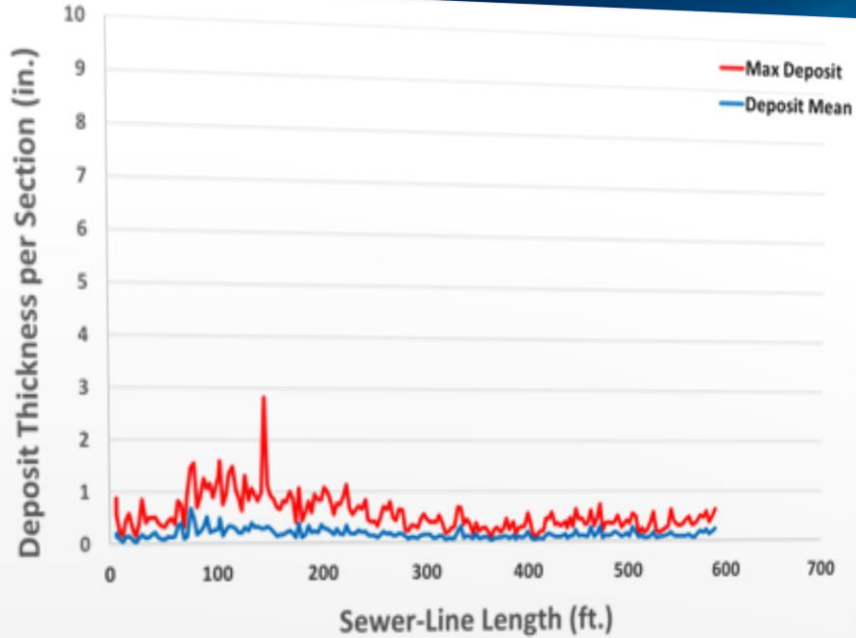
Figure A1.1.1: Deposit thickness per cross-section.

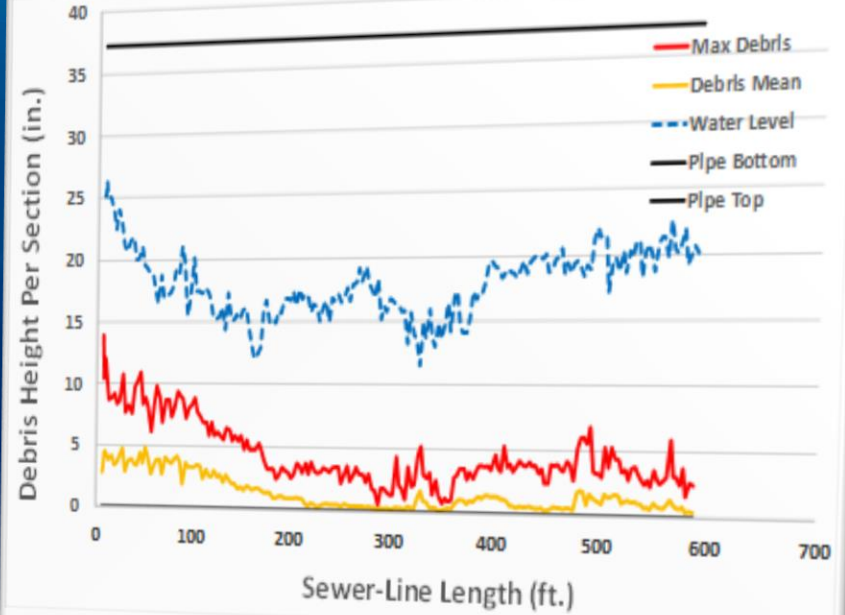
Figure A1.2.1: Debris height per cross-section.

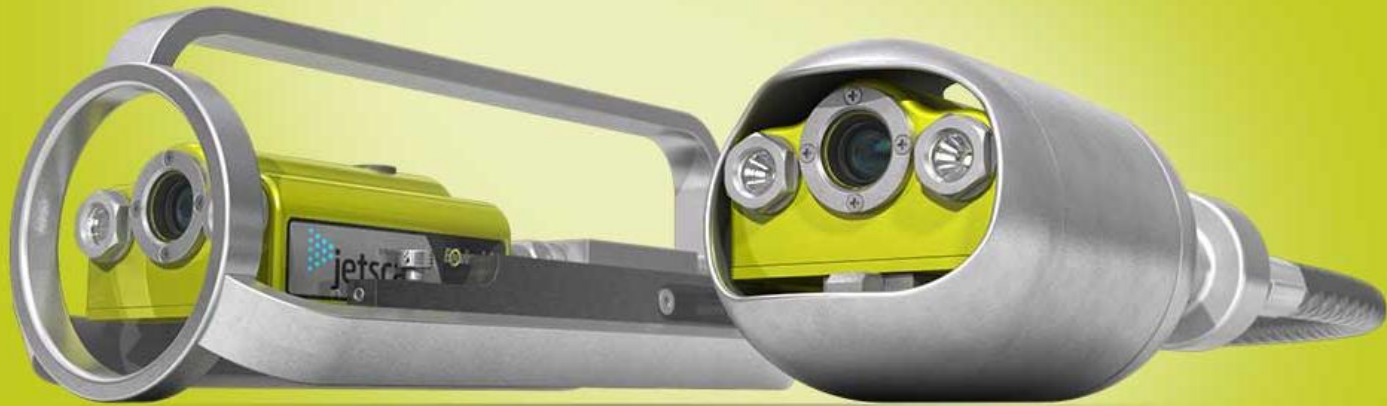
# PREVENTIVE MAINTENANCE: CLEANING “SMARTER” – NEW JETSCAN

**JETSCAN** HD VIDEO NOZZLE

- Crew able verify efficient cleaning performed
- Identify mains needing further assessment
- Immediate determine cause of most SSOs  
(without pulling CCTV rig off current task)

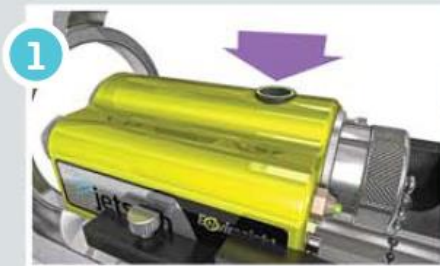
## start recording

Press the record button on the camera.  
It will flash to indicate recording.

# PREVENTIVE MAINTENANCE: CLEANING “SMARTER” – NEW JETSCANRTER

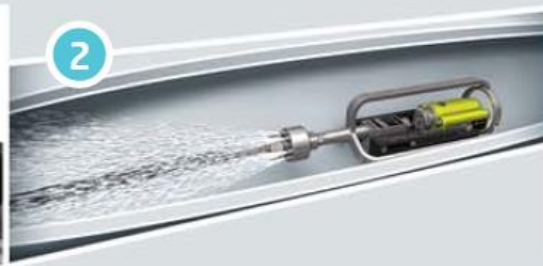
## inspect pipe

Capture footage as JetScan advances  
through the pipe.

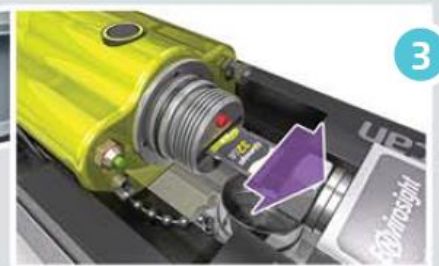
## review footage

After inspection, stop recording and  
eject the memory card to view footage  
on a tablet or PC.
