### APPLICATION OF ASSET MANAGEMENT PRINCIPLES FOR DAMAGE ASSESSMENT AND RECOVERY PLANNING

Esteban Azagra | May 25, 2018

#### Hurricane Sandy and Bay Park STP, Nassau County

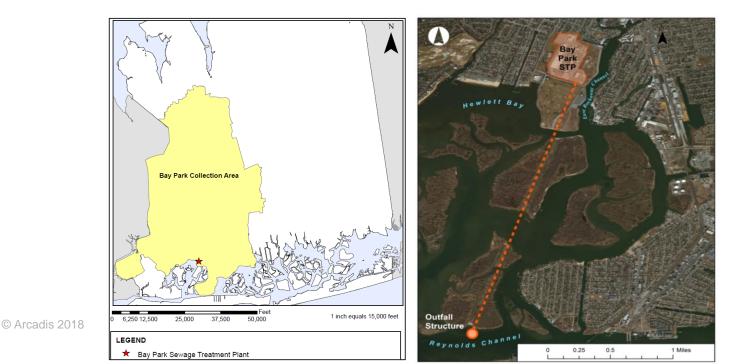
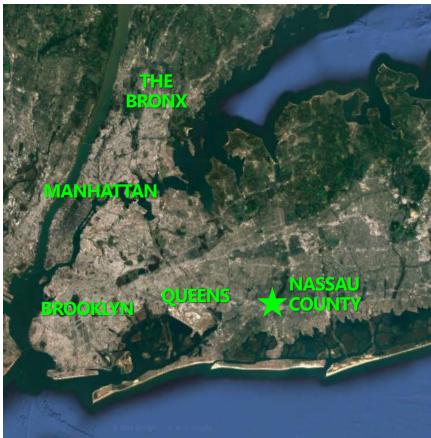
- Hurricane Sandy's high winds, severe flooding, and power outages cause widespread damage to Bay Park Sewage Treatment Plant (STP)
  - ~50 structures, numerous mechanical and electrical systems and operating equipment damaged

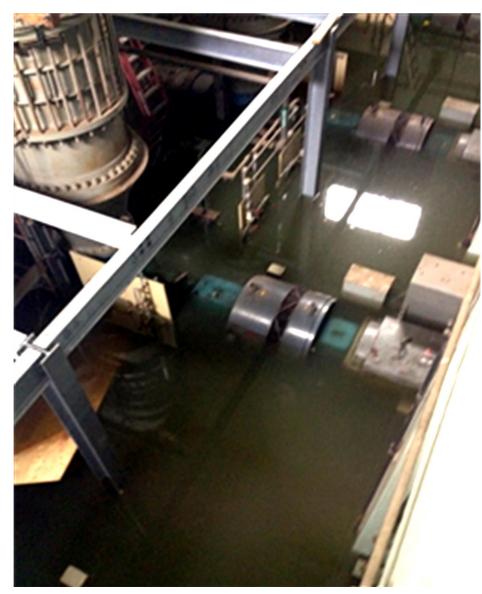
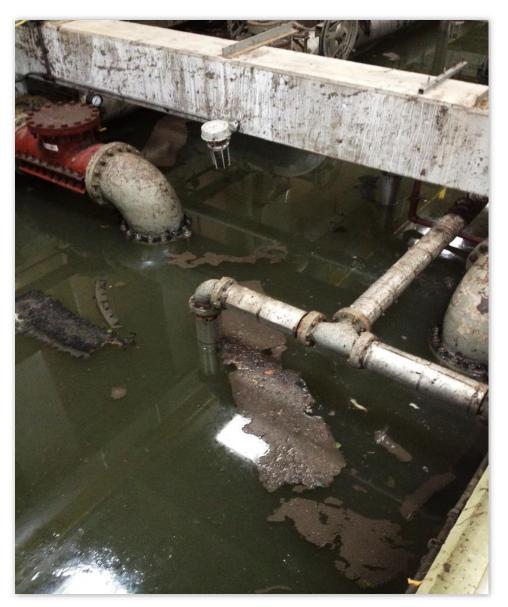
**BASEMENT OF EFFLUENT PLUMPING FACILITY**

#### **Hurricane Sandy Impacts**

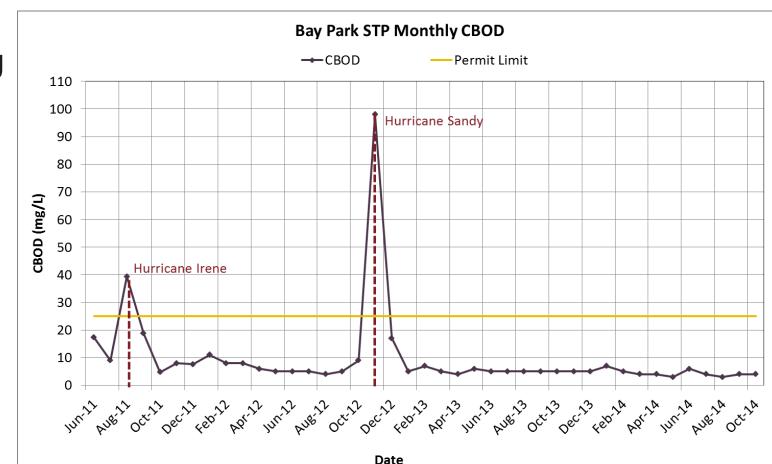
### **Major Equipment and System Failure:**

- ~ 3 Days Total Shutdown & ~ 45 Days Partial Treatment
- ~ 100 million gallons of untreated sewage overflowing into the streets
- ~ 2 Billion Gallons Raw & Partially Treated Waste into Reynolds Channel
- Over \$400M in facility damages

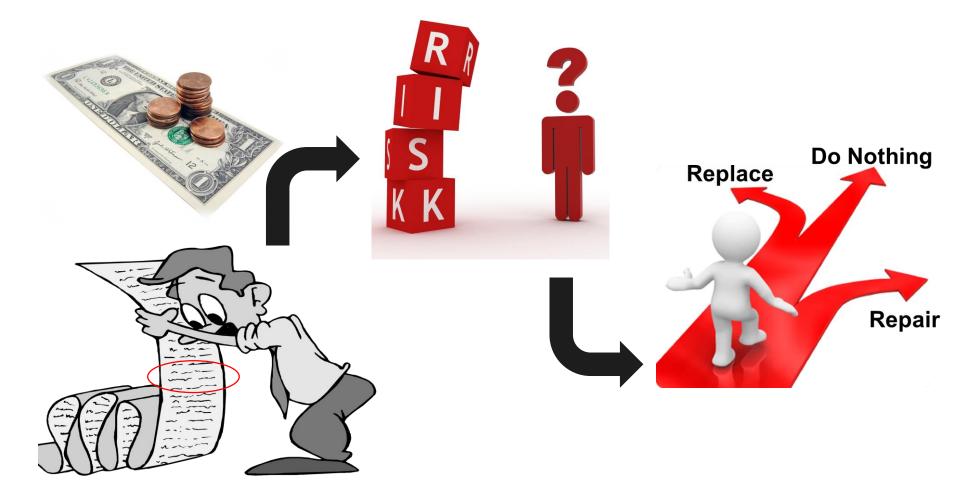
#### **Risk based asset management improves understanding**

#### Risk = Probability(failure) X Consequence(failure)

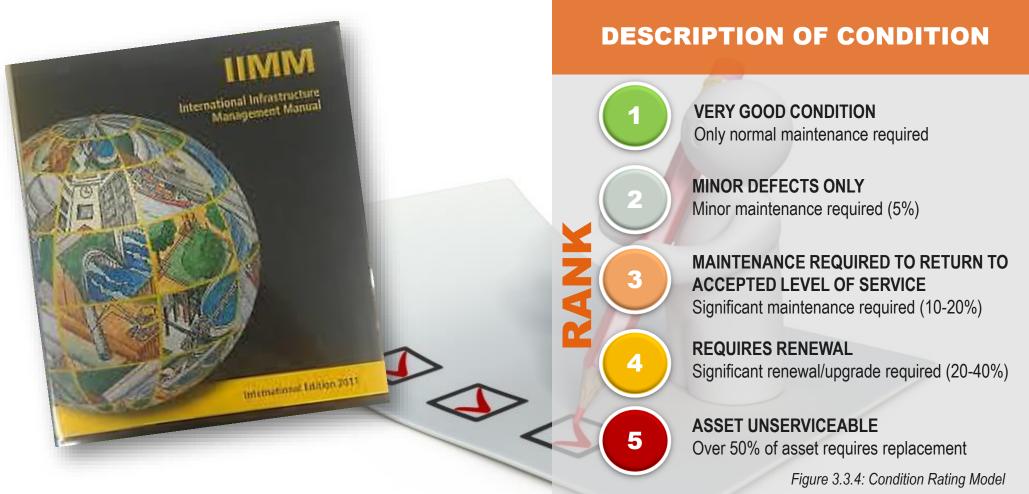
# Visual Assessment is Key for Determining Mortality (also key for determining damage post disaster)

Mechanical Process and HVAC Equipment (includes motor) Visual Condition Assessment							
Criteria	Evaluation	1	2	3	4	5		
	CORE CRITERIA							
Corrosion	Surface only	None	<10%	10% - <25%	25% - 50%	>50%		
Corrosion	Structural (loss of metal)	None	-	-	1 location	>1 location		
Leakage	Gaskets / Connections	None	Historic only	Drip only	Stream 1 location	Stream >1 location		
Leakage	Holes / Failures	None	-	-	1 location	>1 location		
	Vibration Apparent with Noise	None	<10% normal	10% to 20% normal	>20% to 30% normal	>30% normal		
Vibration / Noise	Non-Structural Damage	None	-	-	Yes	-		
	Structural Damage	None	-	-	-	Yes		
	Surface Cracking / Loose Grout	None	<10%	10% - <25%	25% - 50%	>50%		
Concrete Supports	Through Cracks	None	-	<10%	10% - 25%	>25%		
	Damaged / Missing Anchors	None	-	<5% / 1	5% - 20% / 2	>20% / >2		
	Surface Corrosion	None	<10%	10% - <25%	25% - 50%	>50%		
Steel Supports	Structural Corrosion	None	-	<10%	10% -25%	>=25%

Damaged / Missing Anchors	None	-	<5% / 1	5% - 20% / 2	>=20% / >2		
			ANCILLARY CRITE	RIA				
	Leaks – gaskets	None	-	Drips only	Stream – 1 location	Stream - >1 location		
	Leaks – holes / failures	None	-	-	1 location	>1 location		
Piping / Valves	Corrosion - surface	None	<10%	10% - <25%	25% - 50%	>50%		
	Corrosion - structural	None	-	<10%	10% -25%	>25%		
	Support damage	None	-	<5%	5% - 20%	>20%		
	Surface corrosion	None	<10%	10% - <25%	25% - 50%	>50%		
Local Panels	Structural damage	None	-	-	1 location	>1 location		
LUCAI Pallels	Internal corrosion / leakage	None	<10% / none	10% - <25% / none	>=25% / 1 location	>=25% / >1 location		
	Panel Instruments – non-function	None	-	-	1 device or 20%	>1 device or >20%		
Field Instruments	Damaged / non-functional devices	None	-	-	1 device or 20%	>1 device or >20%		
Electrical	Conduit / J. Box - surface corrosion	None	<10%	10% - <25%	25% - 50%	>50%		
Connections	Damage - gaps / missing gaskets	None	-	-	1 location	>1 location

# Visual Assessment is Key for Determining Mortality (also key for determining damage post disaster)

Mechanical Process and HVAC Equipment (includes motor) Visual Condition Assessment						
Criteria	Evaluation	1	2	3	4	5
	·	•	CORE CRITERIA		•	
Corrosion	Surface only	None	<10%	10% - <25%	25% - 50%	>50%
	Structural (loss of metal)	None	-	-	1 location	>1 location
Leakage	Gaskets / Connections	None	Historic only	Drip only	Stream 1 location	Stream >1 location
Leakage	Holes / Failures	None	-	-	1 location	>1 location
	Vibration Apparent with Noise	None	<10% normal	10% to 20% normal	>20% to 30% normal	>30% normal
Vibration / Noise	Non-Structural Damage	None	-	-	Yes	-
	Structural Damage	None	-	-	-	Yes
	Surface Cracking / Loose Grout	None	<10%	10% - <25%	25% - 50%	>50%
Concrete Supports	Through Cracks	None	-	<10%	10% - 25%	>25%
	Damaged / Missing Anchors	None	-	<5% / 1	5% - 20% / 2	>20% / >2
	Surface Corrosion	None	<10%	10% - <25%	25% - 50%	>50%
Steel Supports	Structural Corrosion	None	-	<10%	10% -25%	>=25%
	Damaged / Missing Anchors	None	-	<5% / 1	5% - 20% / 2	>=20% / >2

ANCILLARY CRITE	RIA		
	Leaks – gaskets	None	-	Drips only	Stream – 1 location	Stream - >1 location
	Leaks – holes / failures	None	-	-	1 location	>1 location
Piping / Valves	Corrosion - surface	None	<10%	10% - <25%	25% - 50%	>50%
	Corrosion - structural	None	-	<10%	10% -25%	>25%
	Support damage	None	-	<5%	5% - 20%	>20%
Local Panels	Surface corrosion	None	<10%	10% - <25%	25% - 50%	>50%
	Structural damage	None	-	-	1 location	>1 location
	Internal corrosion / leakage	None	<10% / none	10% - <25% / none	>=25% / 1 location	>=25% / >1 location
	Panel Instruments – non-function	None	-	-	1 device or 20%	>1 device or >20%
Field Instruments	Damaged / non-functional devices	None	-	-	1 device or 20%	>1 device or >20%
Electrical	Conduit / J. Box - surface corrosion	None	<10%	10% - <25%	25% - 50%	>50%
Connections	Damage - gaps / missing gaskets	None	-	-	1 location	>1 location
Connections	Exposed wiring	None	-	-	1 location	>1 location

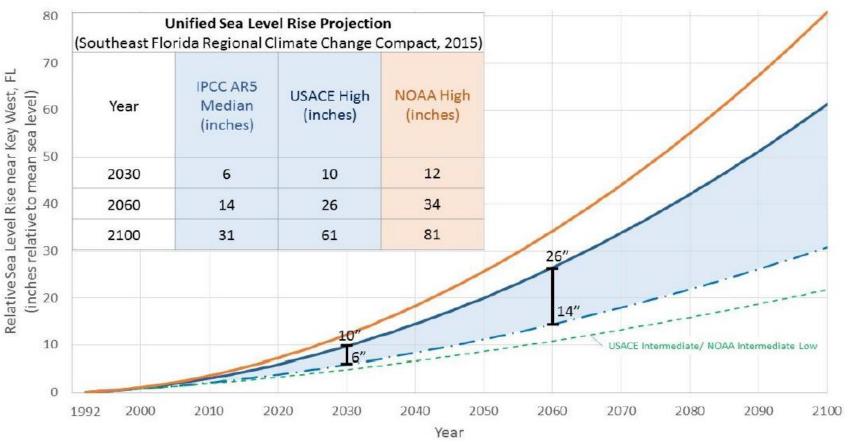
#### **Resilience Scoring: SLR and Storm Surge**

#### Sea Level Rise:

- Chronic flooding:
  - Depth and frequency of recurring flooding
